KOOS & MIKE USED CARS
, VANDERBIJLPARK
Gauteng

DEKRA Vanderbijl Park
Jorissen Str - 1911
VANDERBIJLPARK - GT
016 931 3126

Assignment

VEHICLE INSPECTION

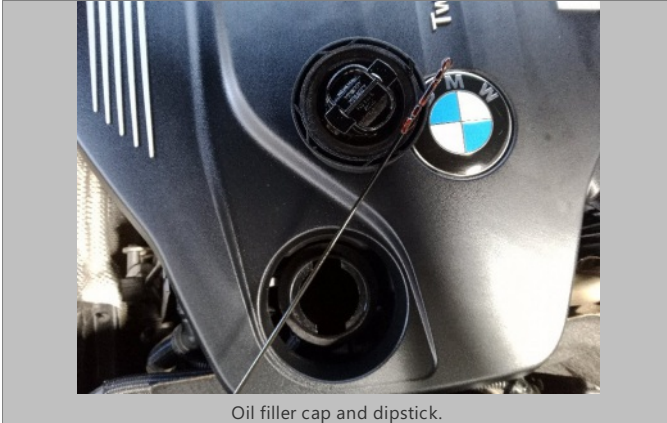
Oil filler cap and dipstick.

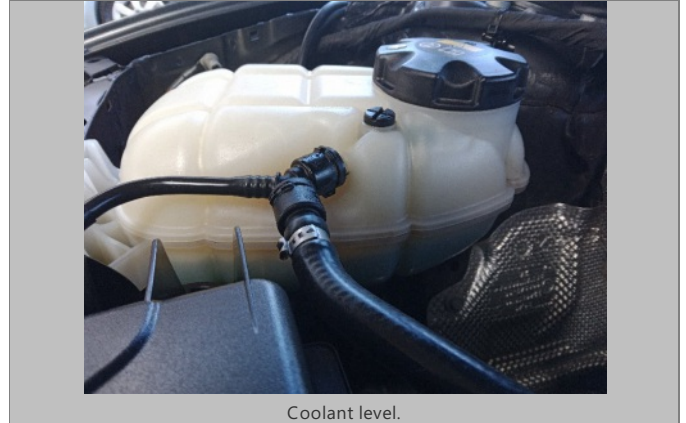
Coolant level.

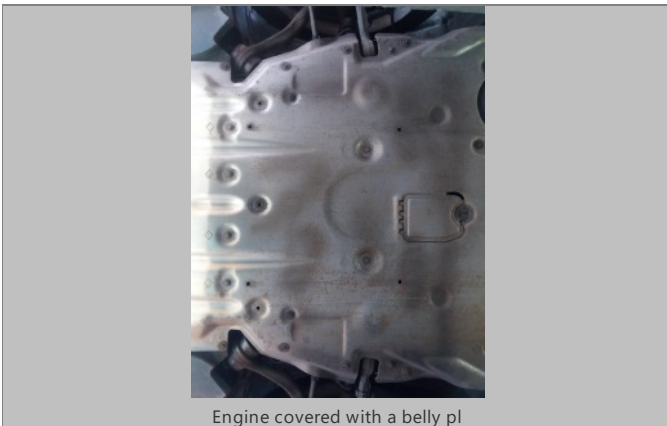
Engine covered with a belly pl

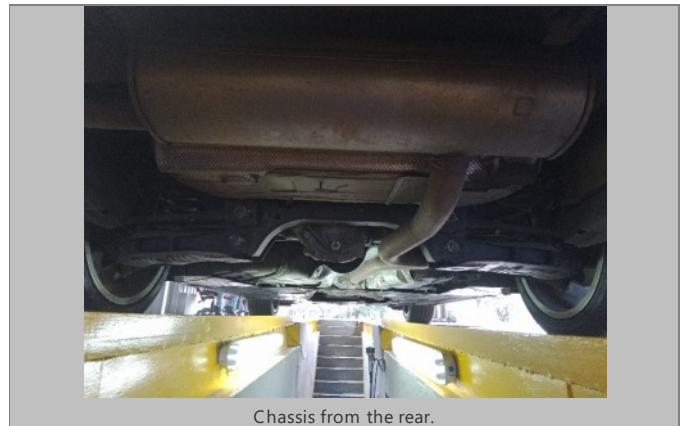
Chassis from the rear.
