KOOS & MIKE USED CARS  
 , VANDERBIJLPARK  
 Gauteng

DEKRA Vanderbijl Park  
 Jorissen Str - 1911  
 VANDERBIJLPARK - GT  
 016 931 3126

**Assignment**

**VEHICLE INSPECTION**

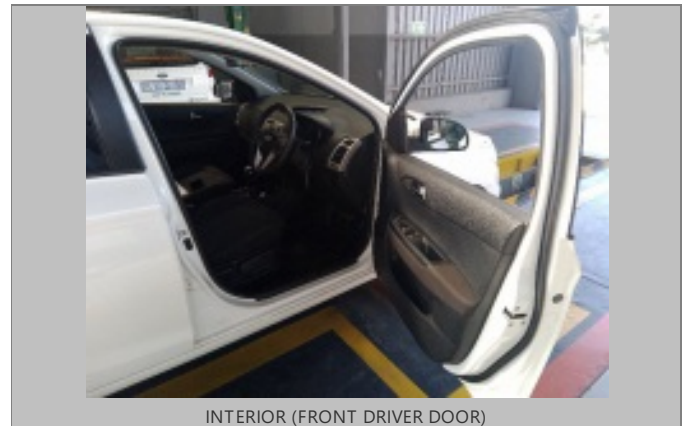
INTERIOR (FRONT DRIVER DOOR)

No negative smell was detected in the vehicle interior. Seats with minor signs of wear including discoloration / fading / stains. Interior trim and/or roof lining and/or carpets show minor signs of wear and/or minor staining. Dashboard with normal signs of wear. The cluster without any defects. The functions of heating and ventilation are without detectable defects. The function of control units and/or instrument cluster is without detectable faults. The testable functions of the air condition is without deficiencies. The function of the electric windows is defect-free. Defects were detected on the electric seats and/or seat heaters. Service due and the service record complete.

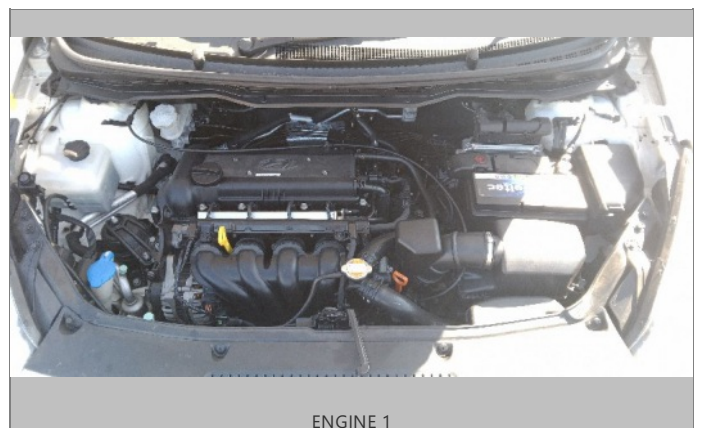
ENGINE 1

The engine-oil level is normal with no visible signs of contamination. The cooling system is without testable defects. The coolant level is normal. The engine shows traces of oil sweat. The gearbox and/or drive shaft show traces of oil sweat. The exhaust system shows signs of damages and/or rust, the functionality is not affected. During the road test no deficiencies were detected on gearshift, clutch, automatic transmissions. During the road test no atypical noises were detected. Minor defects were detected on engine, gearbox, drivetrain - the functionality is not affected.

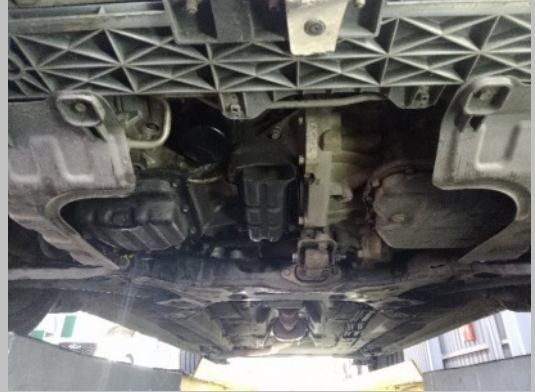
CHASSIS

The break fluid level is normal with no visible signs of contamination. Brake pads and discs show signs of wear & tear. The brake pads and/or discs show signs of wear & tear. The undercarriage with minor damages. Minor defects on axles an / or suspension were detected - the functionality is not affected.
