KOOS & MIKE USED CARS  
 , VANDERBIJLPARK  
 Gauteng

DEKRA Vanderbijl Park  
 Jorissen Str - 1911  
 VANDERBIJLPARK - GT  
 016 931 3126

**Vehicle Data**

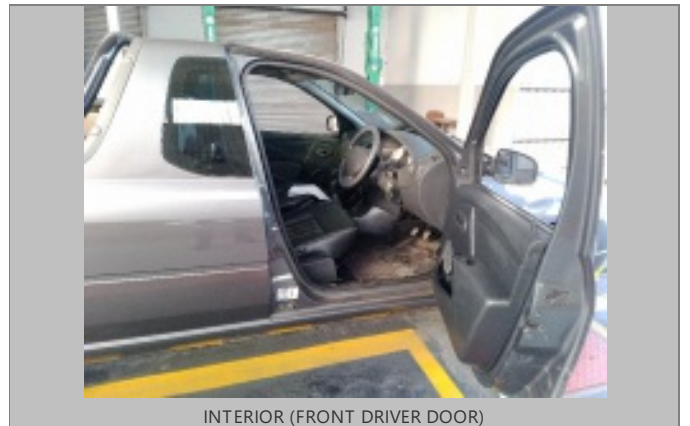
INTERIOR (FRONT DRIVER DOOR)

No negative smell was detected in the vehicle interior. Seats with minor signs of wear including discoloration / fading / stains. Interior trim and/or roof lining and/or carpets show minor signs of wear and/or minor staining. Dashboard with normal signs of wear. The cluster without any defects. The functions of heating and ventilation are without detectable defects. The function of control units and/or instrument cluster is without detectable faults. The testable functions of the air condition is without deficiencies. Defects were detected on the electric seats and/or seat heaters. Service due and the service record complete.

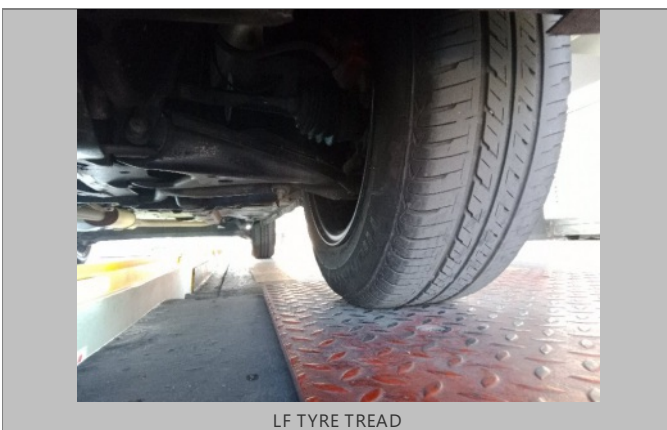
LF TYRE TREAD

Size	Load/Speed Index	Manufacture	Model	Type*	Production Date	Tread Depth (mm)
Front Left	185/65R15	88H	Firestone	Touring	V	1421	2 mm
Front Right	185/65R15	92T	Barum	Brillantis	V	4714	6 mm
Rear Left	185/65R15	88H	Firestone	Touring	V	1622	3 mm
Rear Right	185/65R15	88H	Firestone	Touring	V	2321	3 mm
Spare	185/65R15	92T	Barum	Brillantis	V	0000	8 mm
