KOOS & MIKE USED CARS
 , VANDERBIJLPARK
 Gauteng

DEKRA Vanderbijl Park
 Jorissen Str - 1911
 VANDERBIJLPARK - GT
 016 931 3126

Assignment

VEHICLE INSPECTION

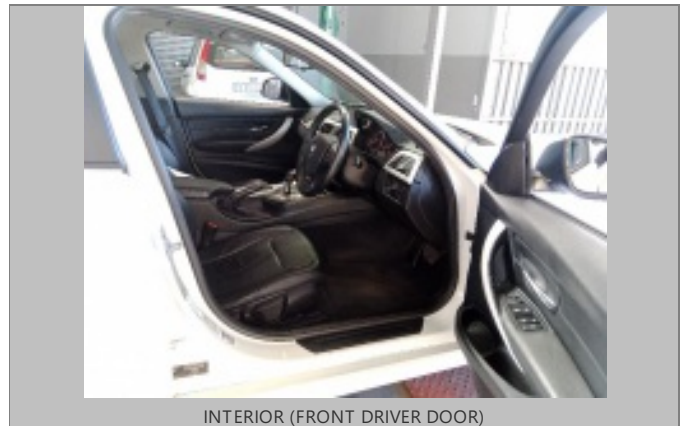
INTERIOR (FRONT DRIVER DOOR)

No negative smell was detected in the vehicle interior. Seats with minor signs of wear including discoloration / fading / stains. Interior trim and/or roof lining and/or carpets show minor signs of wear and/or minor staining. Dashboard with normal signs of wear. The cluster without any defects. The functions of heating and ventilation are without detectable defects. The function of control units and/or instrument cluster is without detectable faults. The testable functions of the air condition is without deficiencies. The function of the electric windows is defect-free. Defects were detected on the electric seats and/or seat heaters. Service due and the service record incomplete.

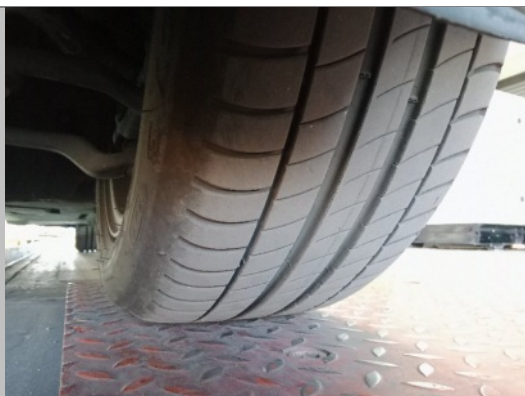
LF TYRE TREAD

| | Size | Load/Speed Index | Manufacture | Model | Type* | Production Date | Tread Depth (mm) |
|---|---|---|---|---|---|---|---|
| Front Left | 225/50R17 | 94W | Michelin | Primacy | V | 3122 | 6 mm |

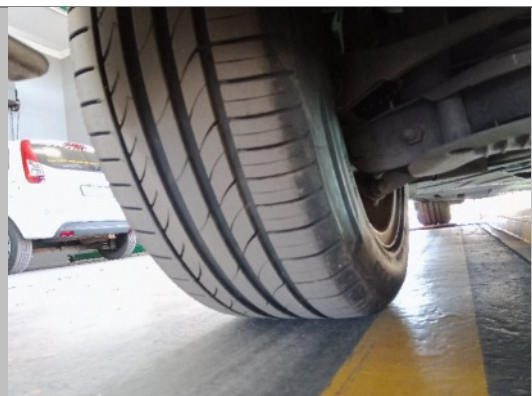
LR TYRE TREAD

| | Size | Load/Speed Index | Manufacture | Model | Type* | Production Date | Tread Depth (mm) |
|---|---|---|---|---|---|---|---|
| Rear Left | 225/50ZR17 | 98Y | Tracmax | Privilo | V | 5123 | 8 mm |

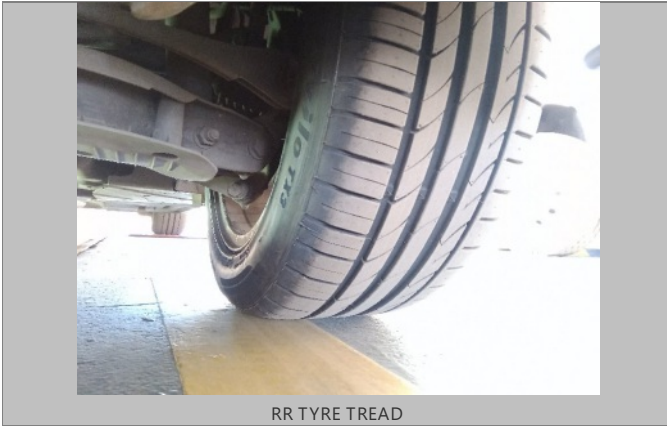
RR TYRE TREAD

| | Size | Load/Speed Index | Manufacture | Model | Type* | Production Date | Tread Depth (mm) |
|---|---|---|---|---|---|---|---|
| Rear Right | 225/50ZR17 | 98Y | Tracmax | Privilo | V | 1224 | 8 mm |

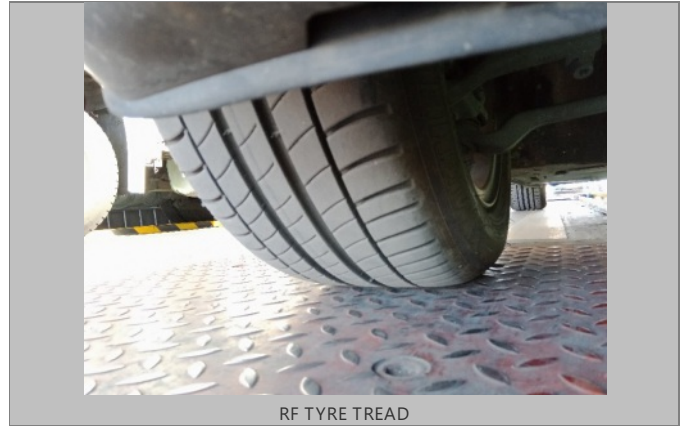
RF TYRE TREAD

| | Size | Load/Speed Index | Manufacture | Model | Type* | Production Date | Tread Depth (mm) |
|---|---|---|---|---|---|---|---|
| Front Right | 225/50R17 | 94W | Michelin | Primacy | V | 5122 | 6 mm |

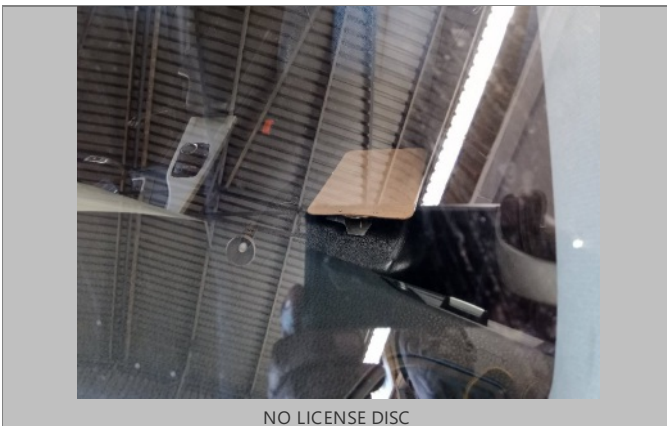
NO LICENSE DISC

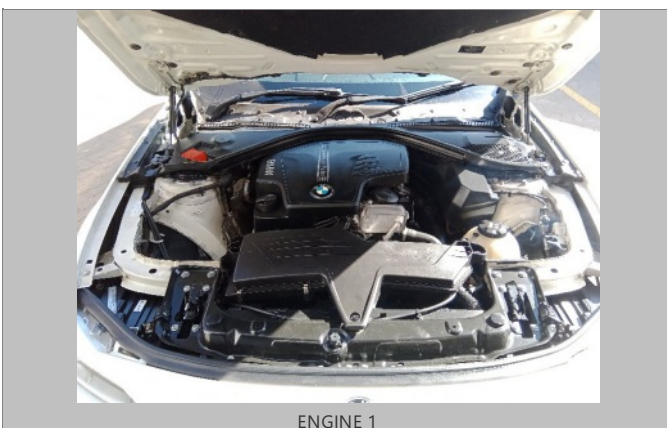
ENGINE 1

The engine-oil level is normal with no visible signs of contamination. The cooling system is without testable defects. The coolant level is normal. The engine shows traces of oil sweat. The gearbox and/or drive shaft show traces of oil sweat. The exhaust system shows signs of damages and/or rust, the functionality is not affected. During the road test no deficiencies were detected on gearshift, clutch, automatic transmissions. During the road test no atypical noises were detected. Minor defects were detected on engine, gearbox, drivetrain - the functionality is not affected.

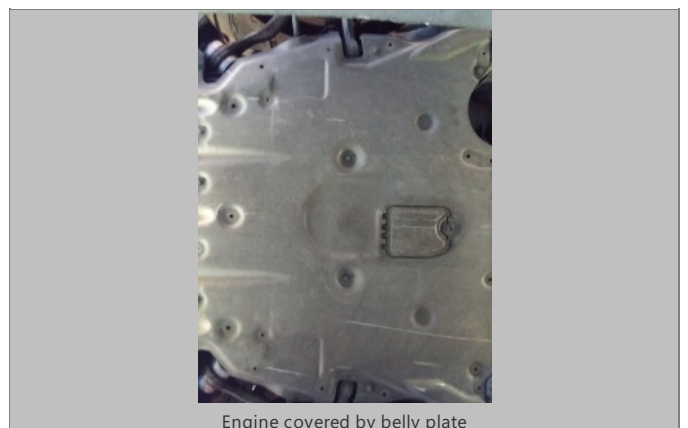
Engine covered by belly plate

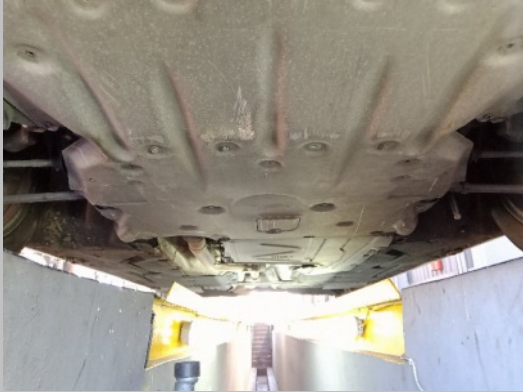
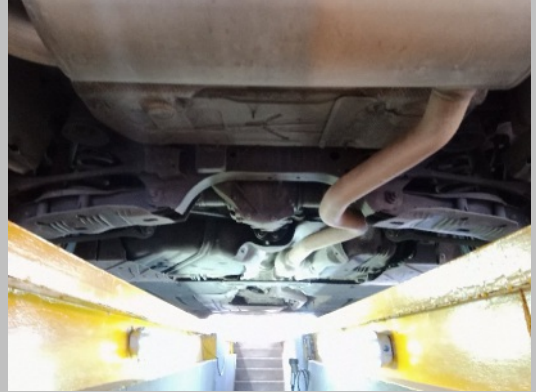
The break fluid level is normal with no visible signs of contamination. Brake pads and discs show signs of wear & tear. The brake pads and/or discs show signs of wear & tear. The undercarriage with minor damages. Minor defects on axles an / or suspension were detected - the functionality is not affected.
