KOOS & MIKE USED CARS
, VANDERBIJLPARK
Gauteng

DEKRA Vanderbijl Park
Jorissen Str - 1911
VANDERBIJLPARK - GT
016 931 3126

VEHICLE INSPECTION

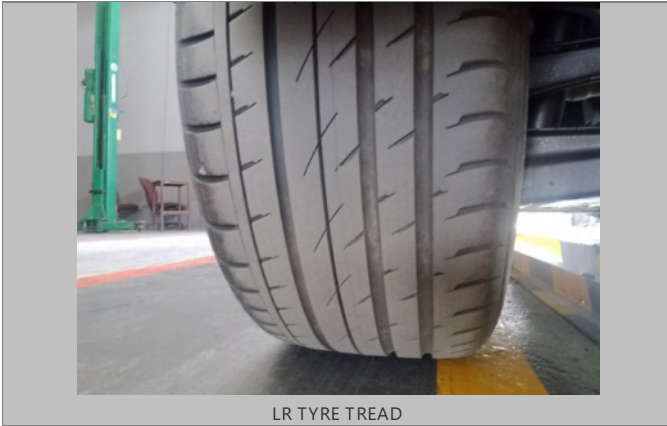
LR TYRE TREAD

| | Size | Load/Speed Index | Manufacture | Model | Type* | Production Date | Tread Depth (mm) |
|---|---|---|---|---|---|---|---|
| Rear Left | 275/45R19 | 101W | Continental | Contisport | V | 1622 | 3 mm |

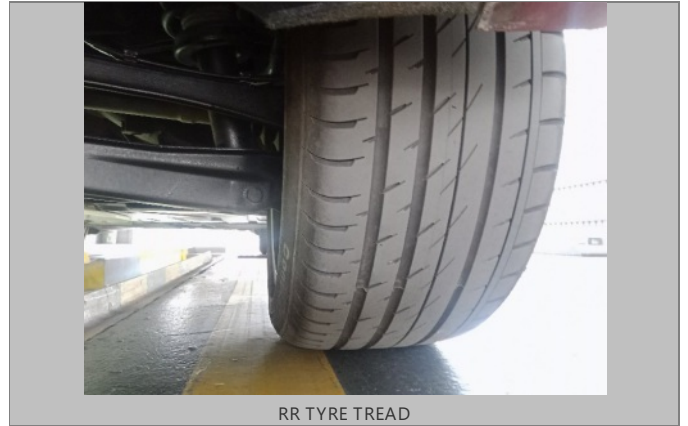
RR TYRE TREAD

| | Size | Load/Speed Index | Manufacture | Model | Type* | Production Date | Tread Depth (mm) |
|---|---|---|---|---|---|---|---|
| Rear Right | 275/40R19 | 101W | Continental | Contisport | V | 1622 | 4 mm |

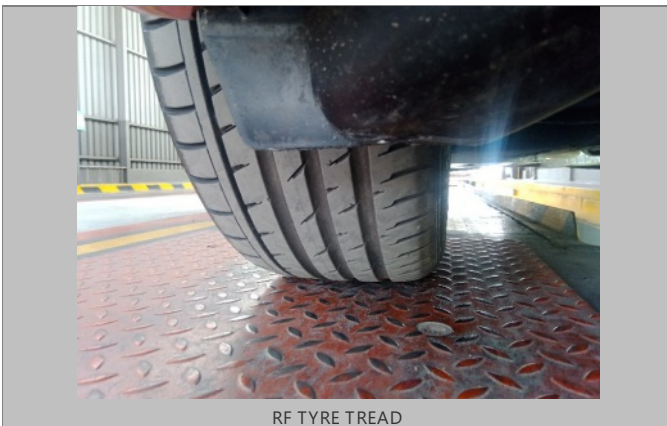
RF TYRE TREAD

| | Size | Load/Speed Index | Manufacture | Model | Type* | Production Date | Tread Depth (mm) |
|---|---|---|---|---|---|---|---|
| Front Right | 245/45R19 | 98W | Continental | Contisport | V | 2022 | 4 mm |
