KOOS & MIKE USED CARS
, VANDERBIJLPARK
Gauteng

Assignment

VEHICLE INSPECTION

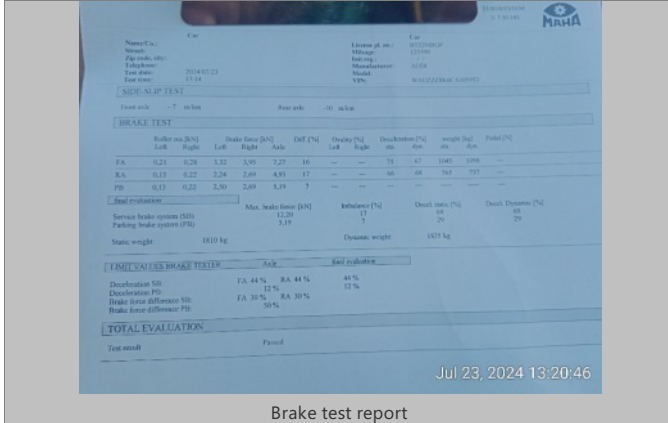
Brake test report

Brake efficiency tested during road test.

Left	Right	Axle Weight [KG]	Deceleration [m/s ²]
	Braking Force [KN]	Braking Force [KN]		
Front	3.3	3.9	-	
Rear	2.2	2.6	-	
Emergency / Parking	2.5	2.6	-

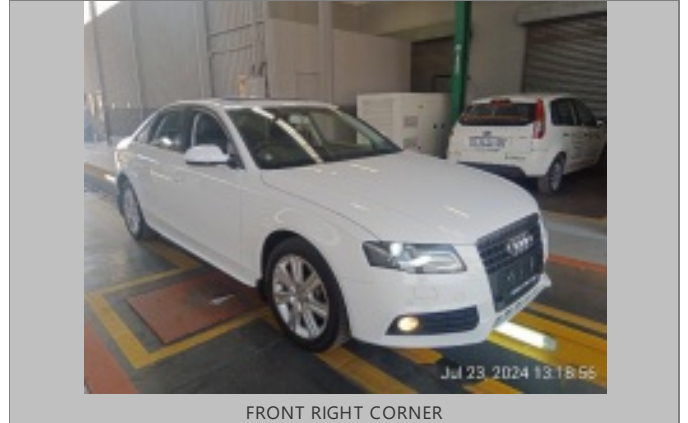
FRONT RIGHT CORNER

General Comments: ACCORDING TO THE AGE AND MILEAGE OF THE VEHICLE, NORMAL WEAR AND TEAR MARKS ARE VISIBLE ON THE INTERIOR, EXTERIOR, ELECTRICAL AND MECHANICAL PARTS. PRE-OWNED INSPECTION ONLY, VEHICLE IS EXEMPT FROM LICENSE.
Body • Exterior: Vehicle have minor chip on some body panels, signs of cosmetic spray paint done to some body panels. Some scratches on front bumper.

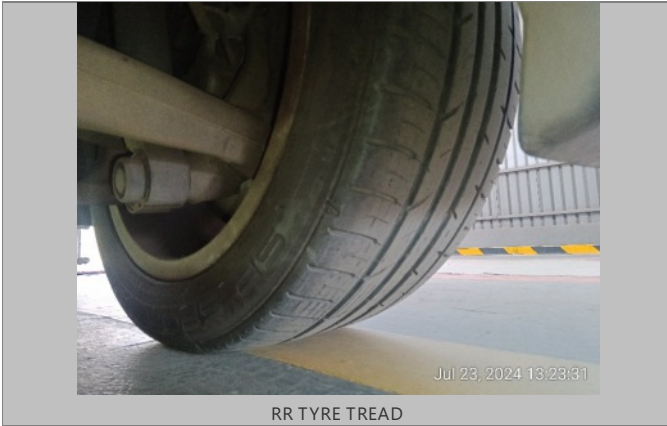
RR TYRE TREAD

Size	Load/Speed Index	Manufacture	Model	Type*	Production Date	Tread Depth (mm)
Front Left	225/50R17	94W	DUNLOP	SPORT	V	3918	3 mm
Front Right	225/50R17	94W	DUNLOP	SPORT	V	4018	3 mm
Rear Left	225/50R17	94W	DUNLOP	SPORT	V	4018	2 mm
Rear Right	225/50R17	94W	DUNLOP	SPORT	V	4018	2 mm
Spare	T 125/70R19	100M	CONTINENTAL	TEMPORARY	V	4711	4 mm

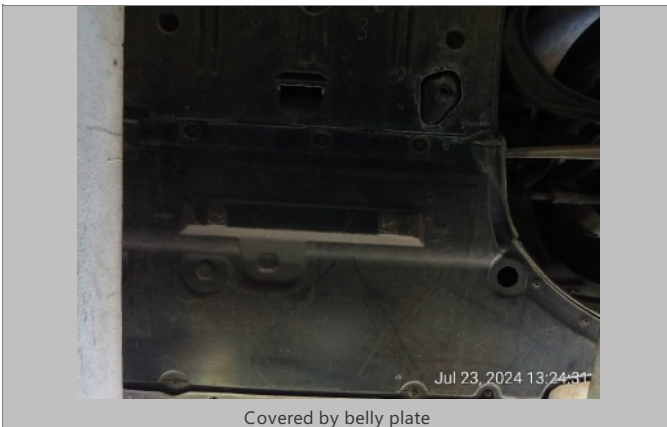
Covered by belly plate
