KOOS & MIKE USED CARS  
, VANDERBIJLPARK  
Gauteng

DEKRA Vanderbijl Park  
Jorissen Str - 1911  
VANDERBIJLPARK - GT  
016 931 3126

**Assignment**

**Vehicle Data**

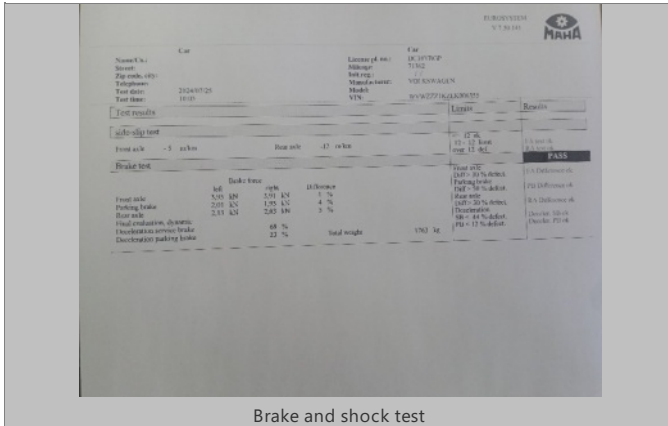
Brake and shock test

Left	Right	Axle Weight [KG]	Deceleration [m/s <sup>2</sup> ]
	Braking Force [KN]	Braking Force [KN]		
Front	3.9	3.9	1073	69.0
Rear	2.1	2.0	690	69.0
Emergency / Parking	2	1.9	690	23

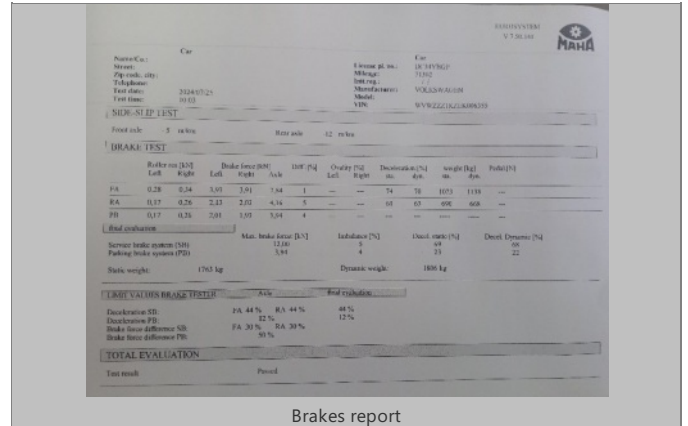
Brakes report

The break fluid level is normal with no visible signs of contamination. Brake pads and discs in good condition and better than wear limit. The brake system in good condition. No damages detected at the undercarriage or undercarriage protection. Axles, Suspension are in a good condition.

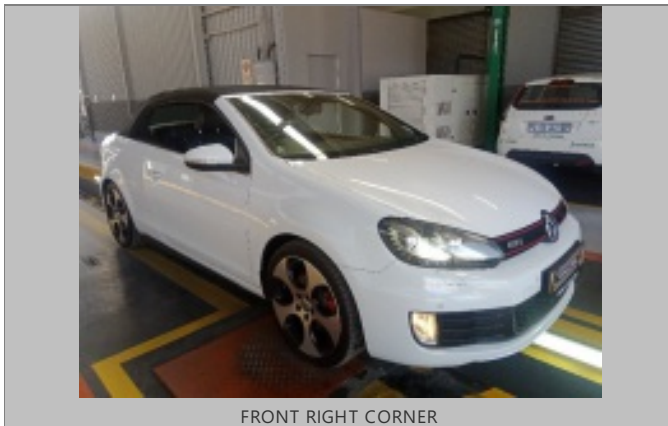
FRONT RIGHT CORNER

Body • Exterior: Minor Dents, Chips and Scratches. Signs of cosmetical improvement on various panels.

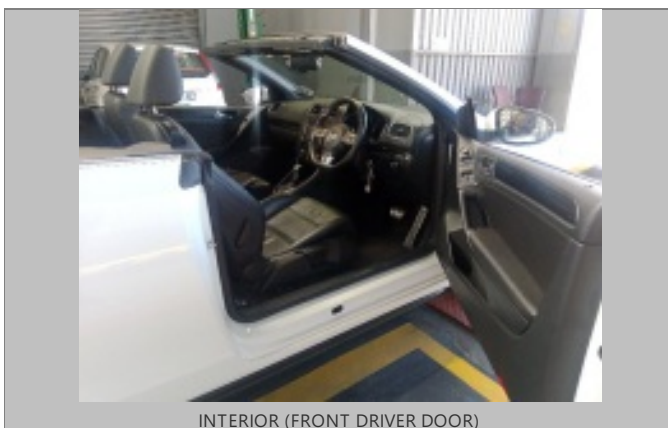
INTERIOR (FRONT DRIVER DOOR)

No negative smell was detected in the vehicle interior. The condition of the seats is good and the seats show no mechanical defects. Interior trim and/or roof lining and/or carpets show no signs of wear and are in a very well kept overall condition. Dashboard with minor signs of wear. The cluster without any defects. The functions of heating and ventilation are without detectable defects. The function of control units and/or instrument cluster is without detectable faults. The testable functions of the air condition is without deficiencies. The function of the electric windows is defect-free. The function of electric sunroof and/or electric soft top is defect-free. Defects were detected on the electric seats and/or seat heaters. Service due and the service record incomplete.
