KOOS & MIKE USED CARS
, VANDERBIJLPARK
Gauteng

Assignment

VEHICLE INSPECTION

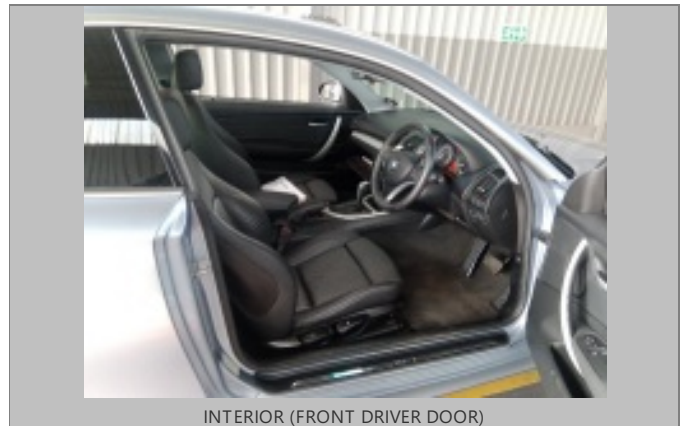
INTERIOR (FRONT DRIVER DOOR)

Interior: According to age & mileage of the vehicle:Normal wear & tear marks on body , interior & mechanical parts

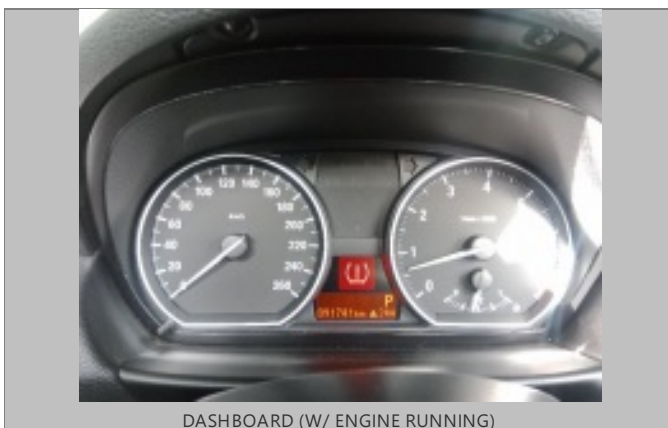
DASHBOARD (W/ ENGINE RUNNING)

Electrical Components and Instruments: Tire pressure warning light.

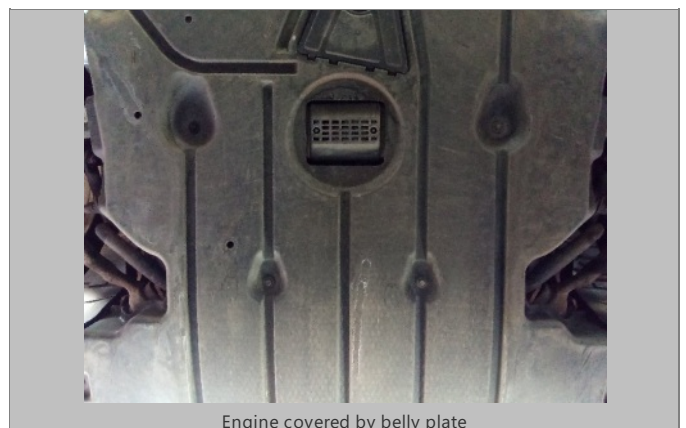
Engine covered by belly plate
