KOOS & MIKE USED CARS  
 , VANDERBIJLPARK  
 Gauteng

DEKRA Vanderbijl Park  
 Jorissen Str - 1911  
 VANDERBIJLPARK - GT  
 016 931 3126

**Assignment**

**Vehicle Data**

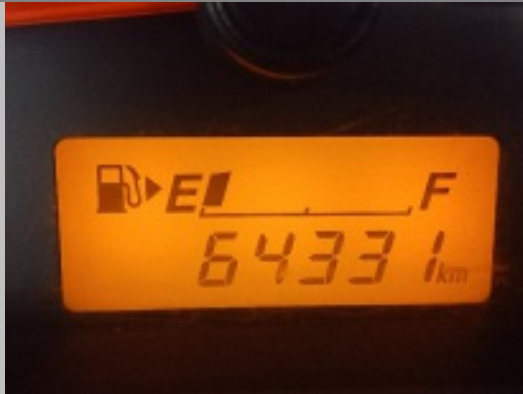
ODOMETER

Vehicle Type	LIGHT LOAD VEHICLE	Registered Owner	KOOS & MIKE
Manufacturer	SUZUKI	Registration Number	KSH016NW
Model	SUPER CARRY	Register Number	DGB906X
VIN	MA3EDA53T00216617	Date Of First Licensing	04/04/2022
Engine Number	G12BN1013682	Last COR	
Doors	2	Last COR	2022/05/06
Color	WHITE	License Expiry Date	30/04/2025
Year Model	2021	Power / Displacement	54kW1196kW
Km Reading	64,331 KM	Paint Finish	C - COMMON
Cab / Body Type	SINGLE CAB	Fuel	PETROL
		Transmission	MANUAL

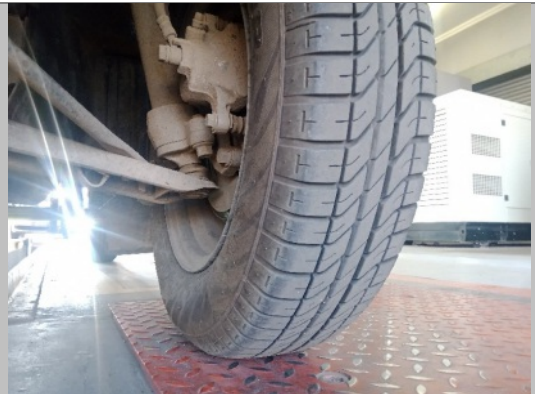
LF TYRE TREAD

Size	Load/Speed Index	Manufacture	Model	Type*	Production Date	Tread Depth (mm)
Front Left	155/80R13	97T	Dunlop	Sport	V	3822	5 mm
Front Right	155/80R13	97T	Dunlop	Sport	V	3522	7 mm
Rear Left	155/80R13	97T	Dunlop	Sport	V	3922	5 mm
Rear Right	155/80R13	97T	Dunlop	Sport	V	3922	5 mm
Spare	155R13	90/89Q	Bridgestone	L607	V	--	8 mm

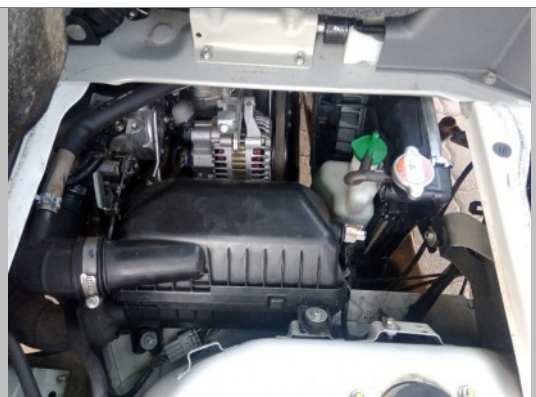
Engine from the right

The engine-oil level is normal with no visible signs of contamination. The cooling system is without testable defects. The coolant level is normal. The engine shows traces of oil sweat. The gearbox and/or drive shaft show traces of oil sweat. The exhaust system shows signs of damages and/or rust, the functionality is not affected. During the road test no deficiencies were detected on gearshift, clutch, automatic transmissions. During the road test no atypical noises were detected. Minor defects were detected on engine, gearbox, drivetrain - the functionality is not affected.
