KOOS & MIKE USED CARS  
, VANDERBIJLPARK  
Gauteng

DEKRA Vanderbijl Park  
Jorissen Str - 1911  
VANDERBIJLPARK - GT  
016 931 3126

**Assignment**

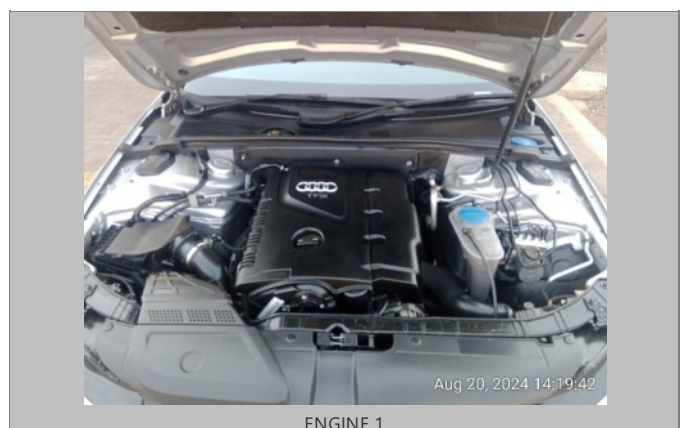
ENGINE 1

The engine-oil level is normal with no visible signs of contamination. The cooling system is without testable defects. The coolant level is normal. The engine shows traces of oil sweat. The gearbox and/or drive shaft show traces of oil sweat. The exhaust system shows signs of damages and/or rust, the functionality is not affected. During the road test no deficiencies were detected on gearshift, clutch, automatic transmissions. During the road test no atypical noises were detected. Minor defects were detected on engine, gearbox, drivetrain - the functionality is not affected.
