KOOS & MIKE USED CARS
, VANDERBIJLPARK
Gauteng

DEKRA Vanderbijl Park
Jorissen Str - 1911
VANDERBIJLPARK - GT
016 931 3126

VEHICLE INSPECTION

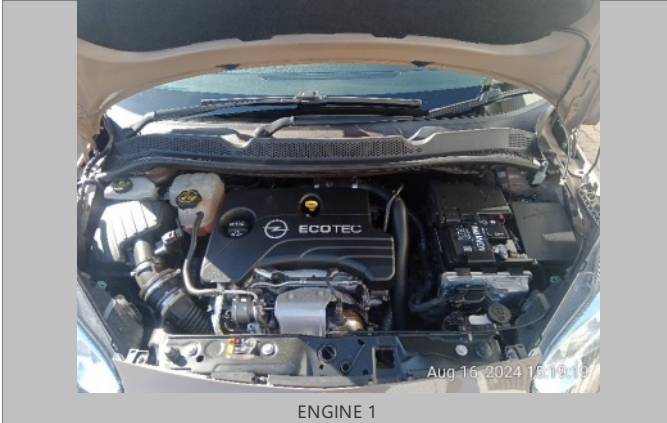
ENGINE 1

The engine-oil level is normal with no visible signs of contamination. The cooling system is without testable defects. The coolant level is normal. The engine shows traces of oil sweat. The gearbox and/or drive shaft show traces of oil sweat. The exhaust system shows signs of damages and/or rust, the functionality is not affected. During the road test no deficiencies were detected on gearshift, clutch, automatic transmissions. During the road test no atypical noises were detected. Minor defects were detected on engine, gearbox, drivetrain - the functionality is not affected.
