KOOS & MIKE USED CARS  
, VANDERBIJLPARK  
Gauteng

DEKRA Vanderbijl Park  
Jorissen Str - 1911  
VANDERBIJLPARK - GT  
016 931 3126

## VEHICLE INSPECTION

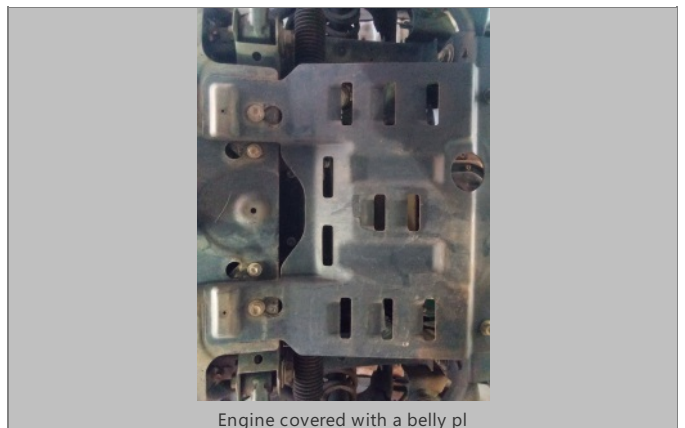
Engine covered with a belly pl
