KOOS & MIKE USED CARS
, VANDERBIJLPARK
Gauteng

Assignment

Vehicle Data

VEHICLE INSPECTION

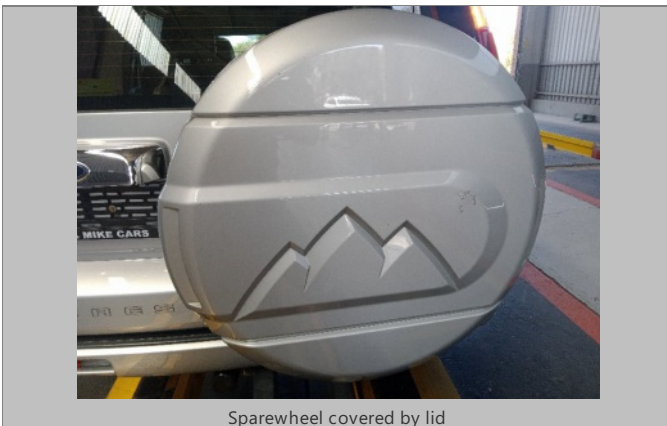
Sparewheel covered by lid
