KOOS & MIKE USED CARS
 , VANDERBIJLPARK
 Gauteng

DEKRA Vanderbijl Park
 Jorissen Str - 1911
 VANDERBIJLPARK - GT
 016 931 3126

Assignment

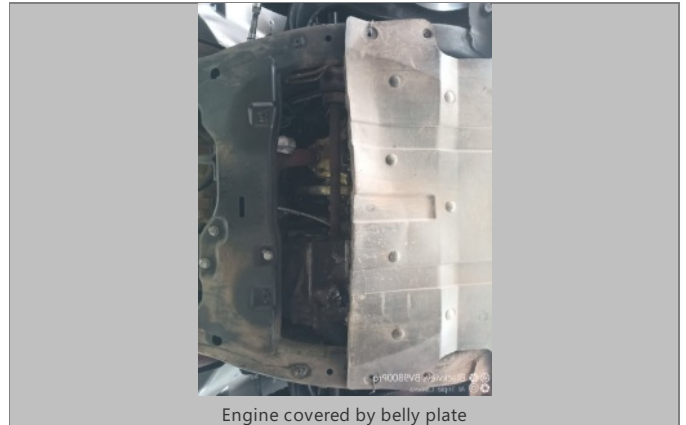
Engine covered by belly plate
