KOOS & MIKE USED CARS
, VANDERBIJLPARK
Gauteng

Assignment

Client	KOOS & MIKE USED CARS	Inspection Location	DEKRA Vanderbijl Park Jorissen Street - 1911 Vanderbijlpark -
Requested Date	25/09/2024		
Inspection Date	25/09/2024

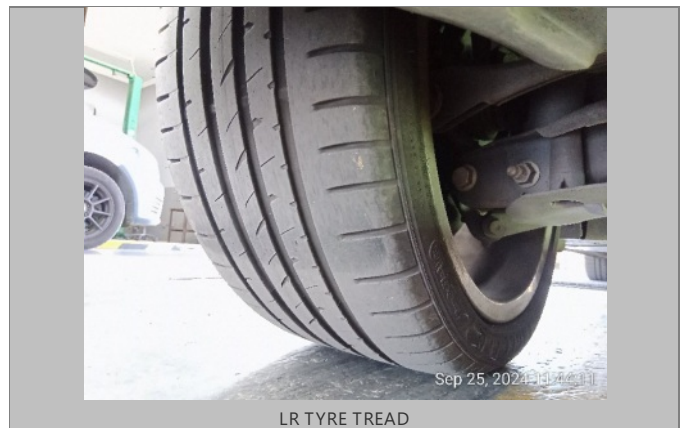
LR TYRE TREAD

Size	Load/Speed Index	Manufacture	Model	Type*	Production Date	Tread Depth (mm)
Front Left	225/40R19	89Y	GoodYear	Eagle	V	2921	5 mm
Front Right	225/40R19	89Y	GoodYear	Eagle	V	4320	6 mm
Rear Left	255/35R19	92Y	GoodYear	Eagle	V	2121	5 mm
Rear Right	255/35R19	92Y	GoodYear	Eagle	V	0821	5 mm

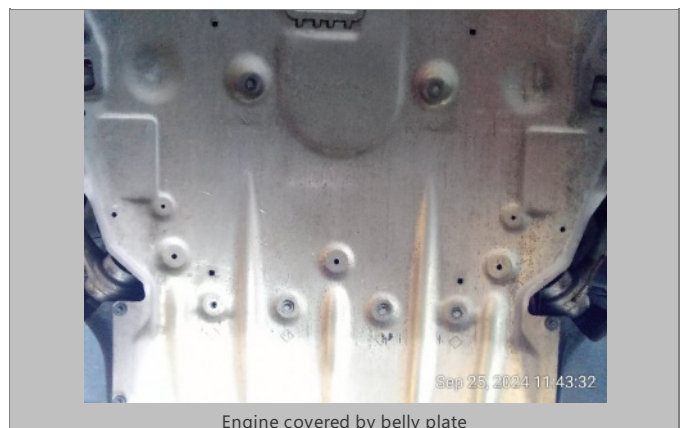
Engine covered by belly plate

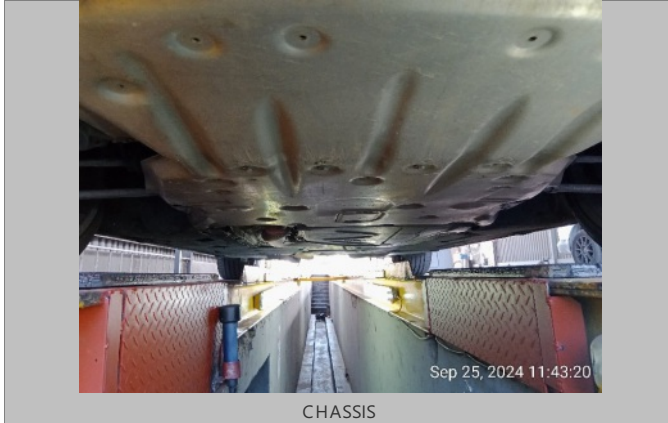
CHASSIS

The break fluid level is normal with no visible signs of contamination. Brake pads and discs show signs of wear & tear. The brake pads and/or discs show signs of wear & tear. The undercarriage with minor damages. Minor defects on axles an / or suspension were detected - the functionality is not affected.
