KOOS & MIKE USED CARS  
, VANDERBIJLPARK  
Gauteng

DEKRA Vanderbijl Park  
Jorissen Str - 1911  
VANDERBIJLPARK - GT  
016 931 3126

## VEHICLE INSPECTION

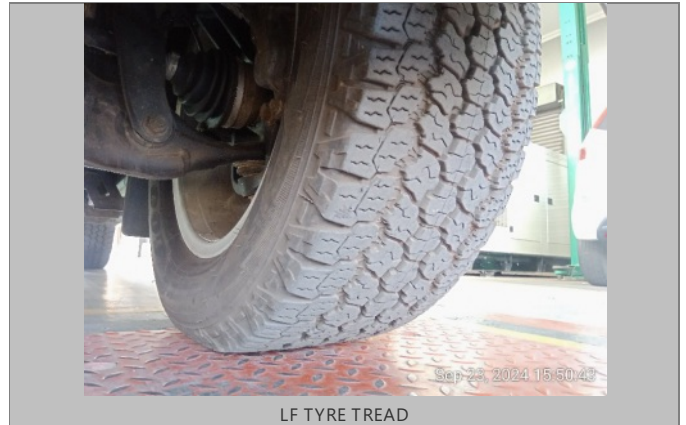
LF TYRE TREAD

| | Size | Load/Speed Index | Manufacture | Model | Type* | Production Date | Tread Depth (mm) |
|---|---|---|---|---|---|---|---|
| Front Left | 265/60R18 | 110H | GoodYear | Wrangler | V | 1921 | 10 mm |

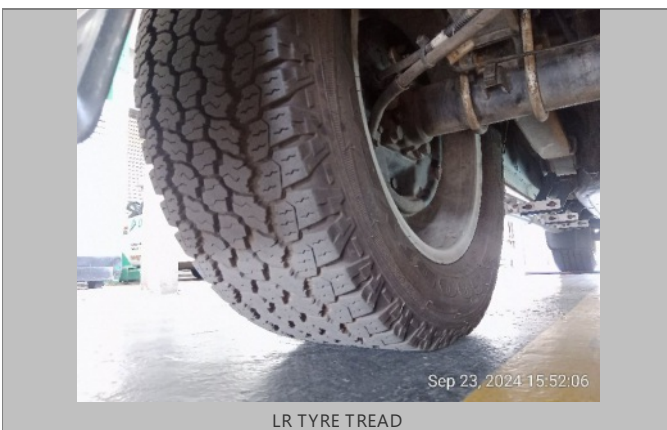
LR TYRE TREAD

| | Size | Load/Speed Index | Manufacture | Model | Type* | Production Date | Tread Depth (mm) |
|---|---|---|---|---|---|---|---|
| Rear Left | 265/60R18 | 110H | GoodYear | Wrangler | V | 1921 | 7 mm |

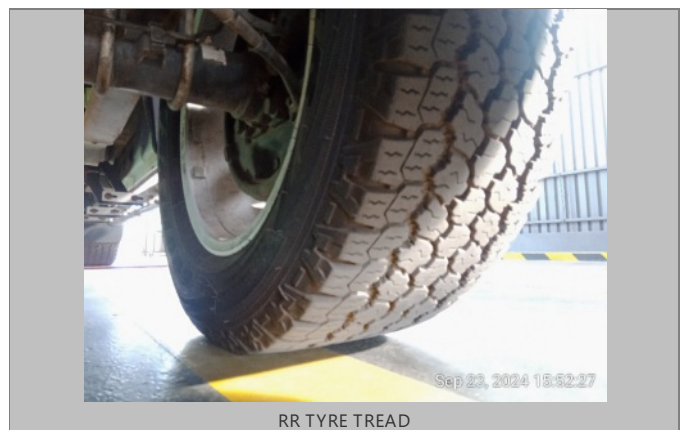
RR TYRE TREAD

| | Size | Load/Speed Index | Manufacture | Model | Type* | Production Date | Tread Depth (mm) |
|---|---|---|---|---|---|---|---|
| Rear Right | 265/60R18 | 110H | GoodYear | Wrangler | V | 1921 | 7 mm |

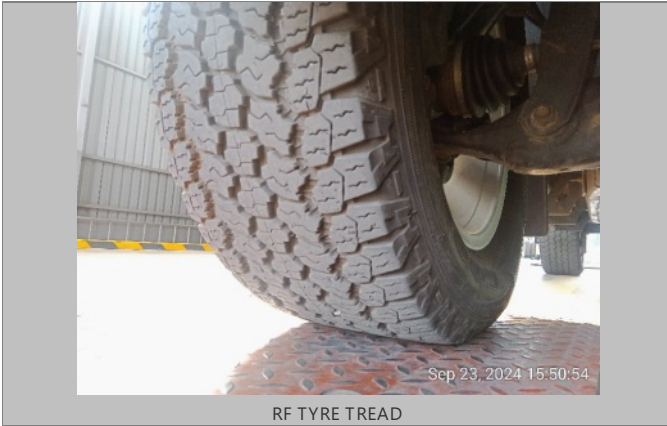
RF TYRE TREAD

| | Size | Load/Speed Index | Manufacture | Model | Type* | Production Date | Tread Depth (mm) |
|---|---|---|---|---|---|---|---|
| Front Right | 265/60R18 | 110H | GoodYear | Wrangler | V | 1921 | 10 mm |

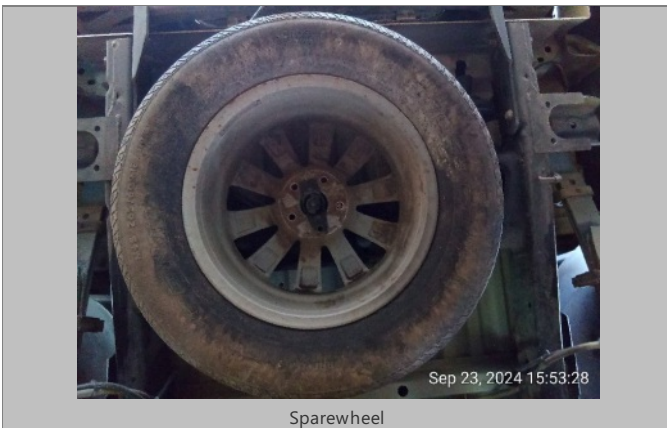
Sparewheel

| | Size | Load/Speed Index | Manufacture | Model | Type* | Production Date | Tread Depth (mm) |
|---|---|---|---|---|---|---|---|
| Spare | 265/60R18 | 110T | Continental | Contact | V | 0000 | 1 mm |

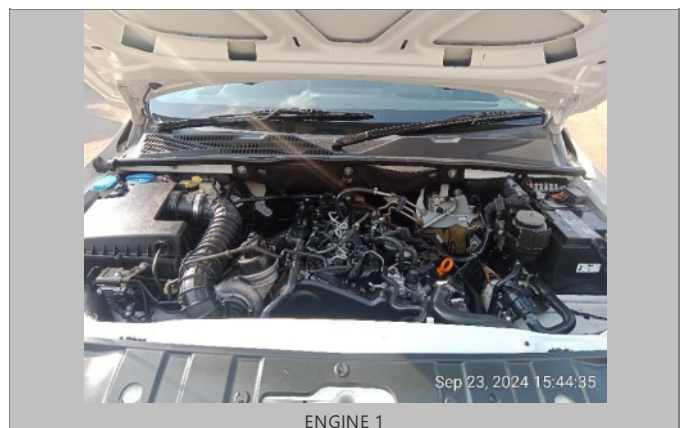
ENGINE 1

Engine Compartment: Oil sweat (observation). Belt assembly noisy.
