KOOS & MIKE USED CARS  
, VANDERBIJLPARK  
Gauteng

DEKRA Vanderbijl Park  
Jorissen Str - 1911  
VANDERBIJLPARK - GT  
016 931 3126

### Vehicle Data

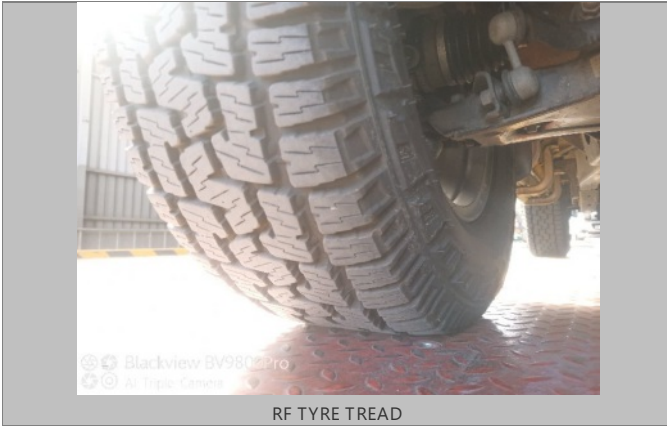
RF TYRE TREAD

Size	Load/Speed Index	Manufacture	Model	Type*	Production Date	Tread Depth (mm)
Front Left	265/65R17	112T	Pirelli	Scorpion	V	0120	9 mm
Front Right	265/65R17	112T	Pirelli	Scorpion	V	0120	9 mm
Rear Left	265/65R17	112T	Pirelli	Scorpion	V	0120	9 mm
Rear Right	265/65R17	112T	Pirelli	Scorpion	V	0120	9 mm
Spare	265/65R17	112S	Bridgestone	Dueler	V	--	9 mm

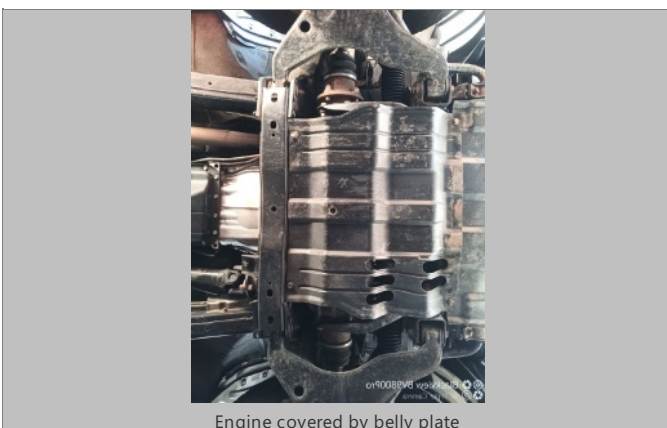
Engine covered by belly plate

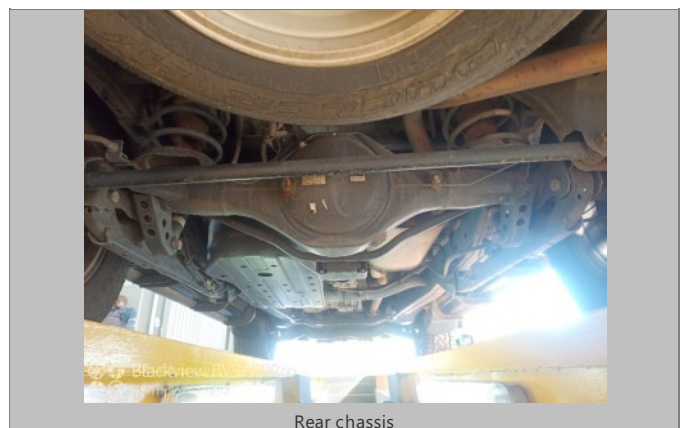
Rear chassis

The brake fluid level is normal with no visible signs of contamination. Brake pads and discs show signs of wear & tear. The brake pads and/or discs show signs of wear & tear. The undercarriage with minor damages. Minor defects on axles an / or suspension were detected - the functionality is not affected.

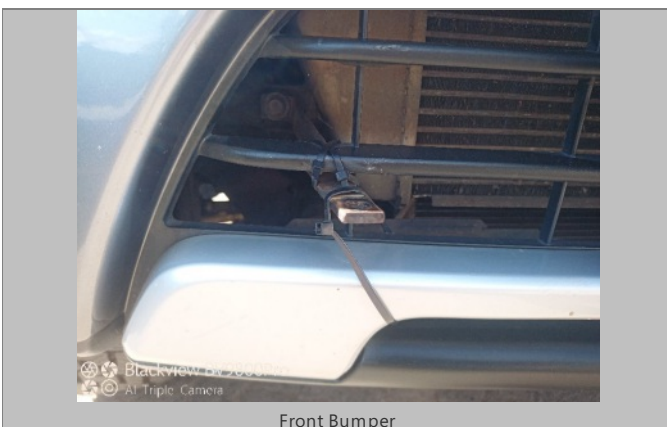
Front Bumper

Body • Exterior: Vehicle has signs of small dents, chips and scratches on some body panels.
