KOOS & MIKE USED CARS
, VANDERBIJLPARK
Gauteng

Assignment

Vehicle Data

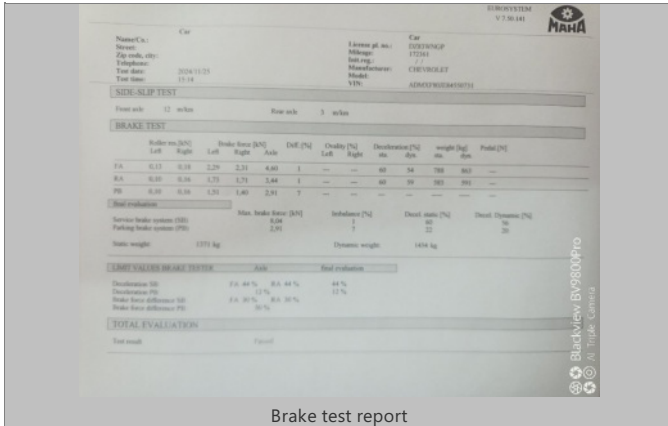
Brake test report

Brake efficiency tested during road test.

Left	Right	Axle Weight [KG]	Deceleration [m/s ²]
	Braking Force [KN]	Braking Force [KN]		
Front	2.29	2.31	-	
Rear	1.73	1.73	-	
Emergency / Parking	1.51	1.4	-

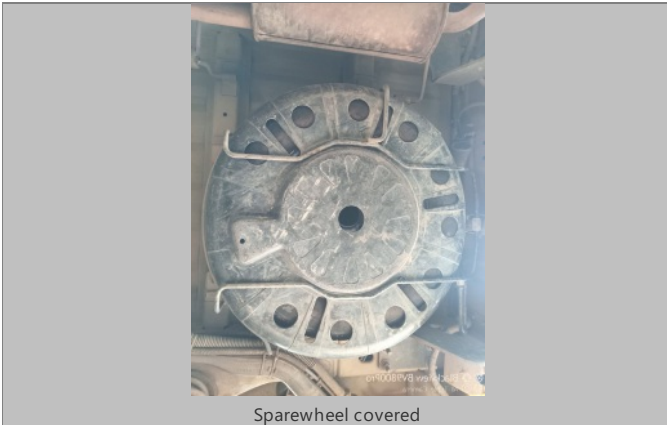
Sparewheel covered
