KOOS & MIKE USED CARS
, VANDERBIJLPARK
Gauteng

Assignment

VEHICLE INSPECTION

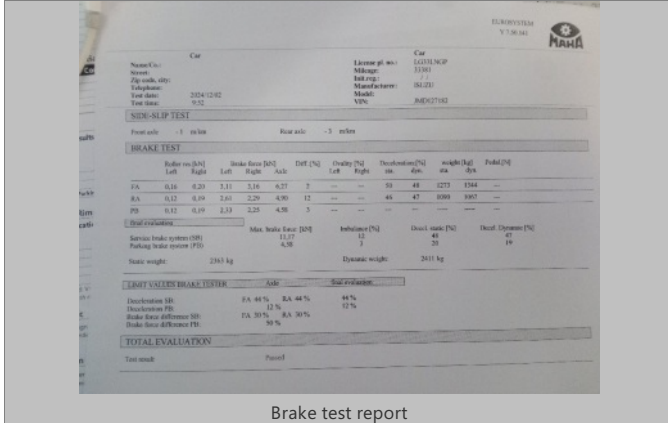
Brake test report

Left	Right	Axle Weight [KG]	Deceleration [m/s ²]
	Braking Force [KN]	Braking Force [KN]		
Front	3.1	3.1	-	
Rear	2.6	2.2	-	
Emergency / Parking	2.3	2.2	-

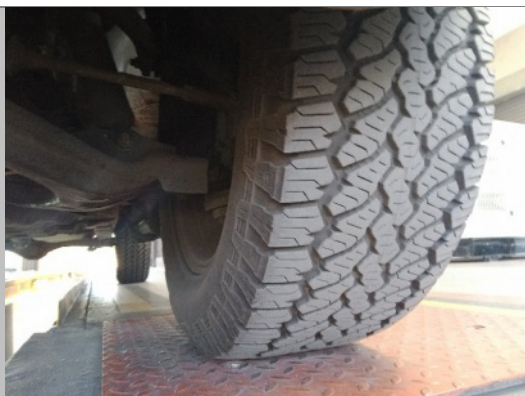
LF TYRE TREAD

Size	Load/Speed Index	Manufacture	Model	Type*	Production Date	Tread Depth (mm)
Front Left	265/60R18	110H	General	Grabber	V	1223	8 mm
Front Right	265/60R18	110H	General	Grabber	V	1223	8 mm
Rear Left	265/60R18	110H	General	Grabber	V	1223	7 mm
Rear Right	265/60R18	110H	General	Grabber	V	1623	6 mm
Spare	265/60R18	110M	General	Grabber	V	0000	10 mm

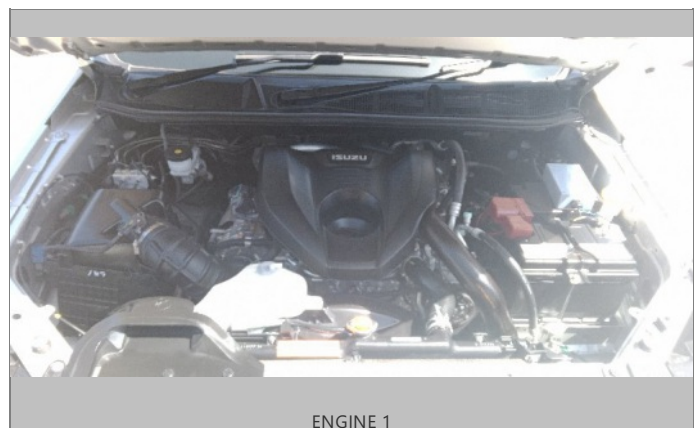
ENGINE 1

The engine-oil level is normal with no visible signs of contamination. The cooling system is without testable defects. The coolant level is normal. The engine shows traces of oil sweat. The gearbox and/or drive shaft show traces of oil sweat. The exhaust system shows signs of damages and/or rust, the functionality is not affected. During the road test no deficiencies were detected on gearshift, clutch, automatic transmissions. During the road test no atypical noises were detected. Minor defects were detected on engine, gearbox, drivetrain - the functionality is not affected.
