KOOS & MIKE USED CARS
 , VANDERBIJLPARK
 Gauteng

Assignment

Vehicle Type	PASSENGER VEHICLE	Registered Owner	KOOS AND MIKE USED CARS
Manufacturer	RENAULT	Registration Number	FJ78BJGP
Model	SANDERO	Register Number	WWK654W
VIN	VF15SRAAC54520395	Date Of First Licensing	12/07/2016
Engine Number	COVERED	Last COR	
Doors	5	Last COR	12/08/2022
Color	SILVER	License Expiry Date	31/03/2023
Year Model	2016	Power / Displacement	66kw899cc
Km Reading	101,873 KM	Paint Finish	M - METALLIC
Cab / Body Type	HATCHBACK	Fuel	PETROL
		Transmission	MANUAL

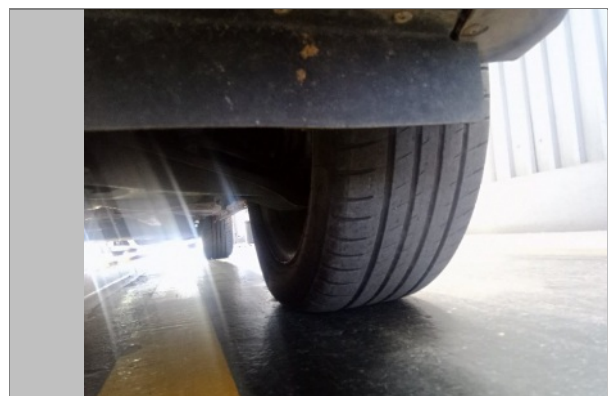
LF TYRE TREAD

Size	Load/Speed Index	Manufacture	Model	Type*	Production Date	Tread Depth (mm)
Front Left	205/55R16	91V	Blackarrow	Sport	V	1322	3 mm
Front Right	205/55R16	91V	Blackarrow	Sport	V	1322	3 mm
Rear Left	205/55R16	1322	Blackarrow	Sport	V	1322	4 mm
Rear Right	205/55R16	91V	Blackarrow	Sport	V	1322	4 mm
Spare	185/65R15	88T	Barum	Brillantis	V	5015	8 mm

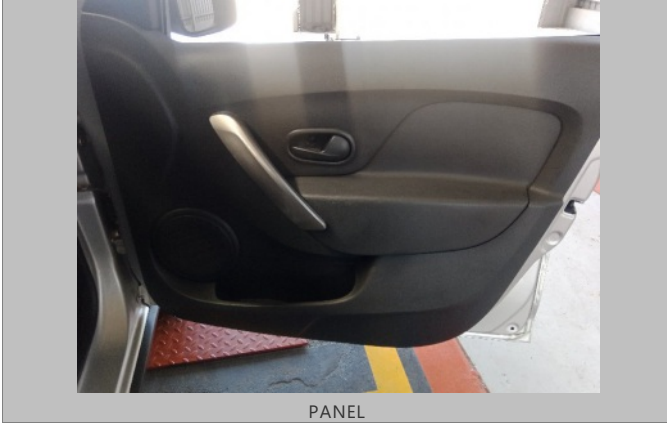
PANEL

Body • Exterior: Minor Dents, Chips and Scratches. Signs of cosmetical improvement on various panels.
