KOOS & MIKE USED CARS
, VANDERBIJLPARK
Gauteng

Assignment

Vehicle Type	PASSENGER VEHICLE	Registered Owner	KOOS AND MIKE USED CARS
Manufacturer	KIA	Registration Number	DR96PNGP
Model	SOUL	Register Number	VVV454W
VIN	KNAJP811LF7196657	Date Of First Licensing	19/05/2015
Engine Number	G3FGFH816528	Last COR	
Doors	5	Last COR	2023/12/18
Color	SILVER	License Expiry Date	31/07/2024
Year Model	2015	Power / Displacement	91kW. 1591cc
Km Reading	61,697 KM	Paint Finish	M - METALLIC
Cab / Body Type	HATCHBACK	Fuel	PETROL
		Transmission	MANUAL

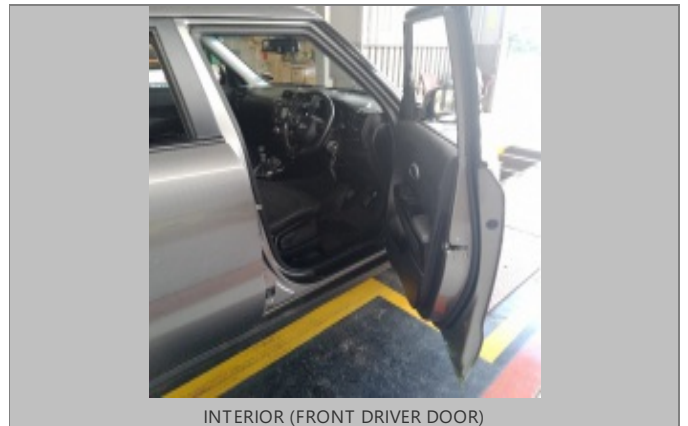
INTERIOR (FRONT DRIVER DOOR)

No negative smell was detected in the vehicle interior. Seats with minor signs of wear including discoloration / fading / stains. Interior trim and/or roof lining and/or carpets show minor signs of wear and/or minor staining. Dashboard with normal signs of wear. The cluster without any defects. The functions of heating and ventilation are without detectable defects. The function of control units and/or instrument cluster is without detectable faults. The testable functions of the air condition is without deficiencies. The function of the electric windows is defect-free. Defects were detected on the electric seats and/or seat heaters. Service due and the service record complete.

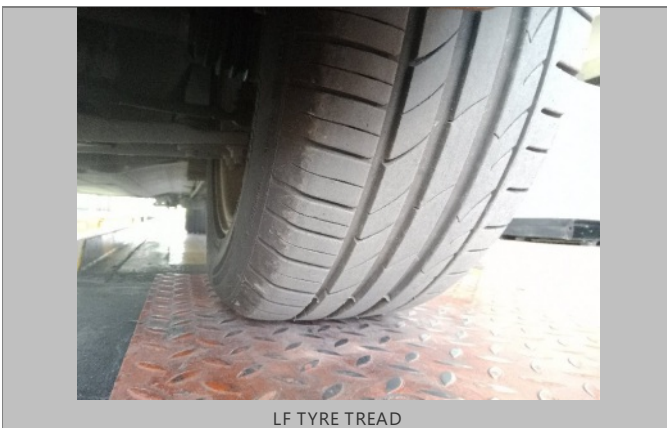
LF TYRE TREAD

Size	Load/Speed Index	Manufacture	Model	Type*	Production Date	Tread Depth (mm)
Front Left	215/55R17	98W	Argos	Adking	V	1123	6 mm
Front Right	215/55R17	98W	Argos	Adking	V	1153	6 mm
Rear Left	P215/55R17	94W	Nexent	NFera	V	2015	5 mm
Rear Right	P215/55R17	94W	Nexen	NFera	V	4215	4 mm
Spare	125/80D16	97M	Haankook	Temporary	V	----	4 mm

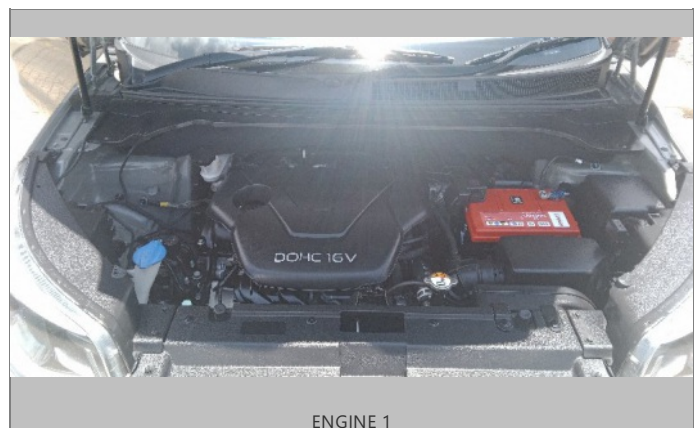
ENGINE 1

The engine-oil level is normal with no visible signs of contamination. The cooling system is without testable defects. The coolant level is normal. The engine shows traces of oil sweat. The gearbox and/or drive shaft show traces of oil sweat. The exhaust system shows signs of damages and/or rust, the functionality is not affected. During the road test no deficiencies were detected on gearshift, clutch, automatic transmissions. During the road test no atypical noises were detected. Minor defects were detected on engine, gearbox, drivetrain - the functionality is not affected.
