KOOS & MIKE USED CARS  
, VANDERBIJLPARK  
Gauteng

DEKRA Vanderbijl Park  
Jorissen Str - 1911  
VANDERBIJLPARK - GT  
016 931 3126

## VEHICLE INSPECTION

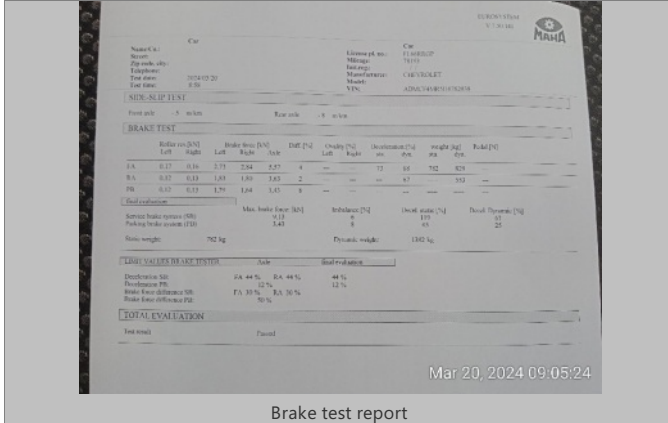
Brake test report

Brake efficiency tested during road test.

| | Left | Right | Axle Weight [KG] | Deceleration [m/s <sup>2</sup> ] |
| | Braking Force [KN] | Braking Force [KN] | | |
| Front | 2.7 | 2.8 | - | |
| Rear | 1.8 | 1.8 | - | |
| Emergency / Parking | 1.7 | 1.6 | - | |

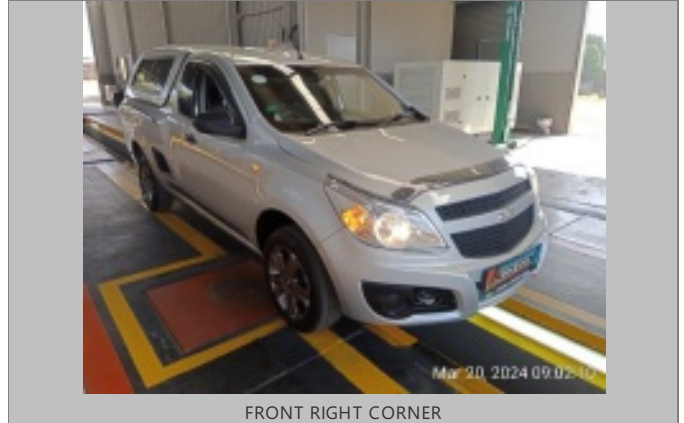
FRONT RIGHT CORNER

The rims show no defects which affect the function. The mechanics of doors / bonnet / tailgate are defect-free. No residual traces of damage repair were detected. The vehicle shows normal signs of wear & tear according to age and milage. Vehicle Body with several dents or scratches or corrosion (edge corrosion / surface corroded). Minor paint damage to the primer were detected. The glass panes have stone chips and/or scratches. Hang-on parts (grill, bumpers, mirrors, antennas, strips, etc.) show minor damages. The spare tire / emergency wheel / repair set shows signs of wear & tear. The tire tread depth is more than 1 mm. The tires are in good condition

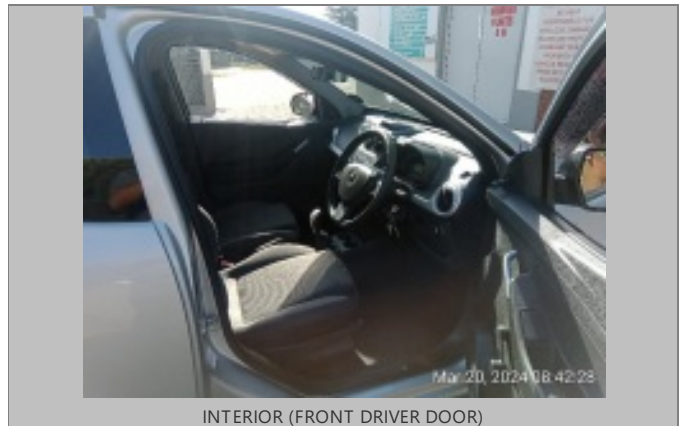
INTERIOR (FRONT DRIVER DOOR)

No negative smell was detected in the vehicle interior. Seats with minor signs of wear including discoloration / fading / stains. Interior trim and/or roof lining and/or carpets show minor signs of wear and/or minor staining. Dashboard with normal signs of wear. The cluster without any defects. The functions of heating and ventilation are without detectable defects. The function of control units and/or instrument cluster is without detectable faults. The testable functions of the air condition is without deficiencies. Defects were detected on the electric seats and/or seat heaters. Service due and the service record complete.

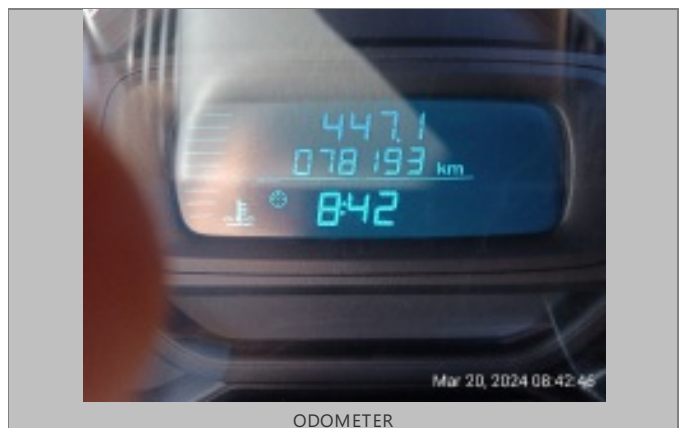
ODOMETER

| Km Reading | 78,193 KM | Paint Finish | M - METALLIC |

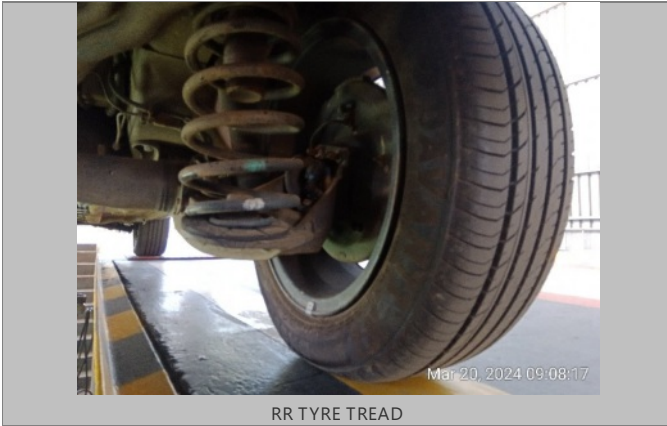
RR TYRE TREAD

| | Size | Load/Speed Index | Manufacture | Model | Type* | Production Date | Tread Depth (mm) |
|---|---|---|---|---|---|---|---|
| Rear Right | 185/60R15 | 88H | DAVANTI | DX890 | V | 2523 | 5 mm |

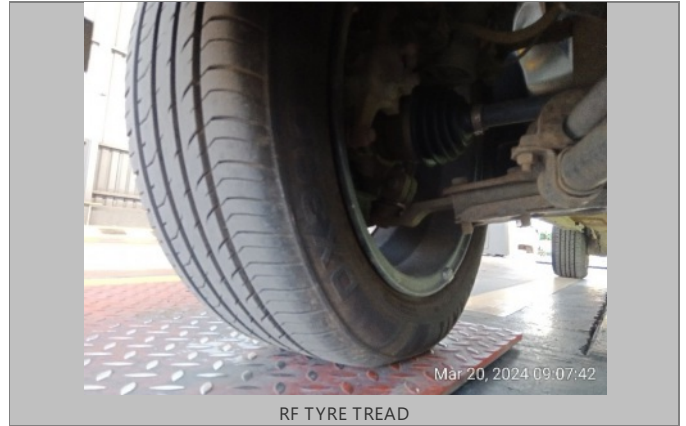
RF TYRE TREAD

| | Size | Load/Speed Index | Manufacture | Model | Type* | Production Date | Tread Depth (mm) |
|---|---|---|---|---|---|---|---|
| Front Right | 185/60R15 | 88H | DAVANTI | DX890 | V | 2423 | 4 mm |

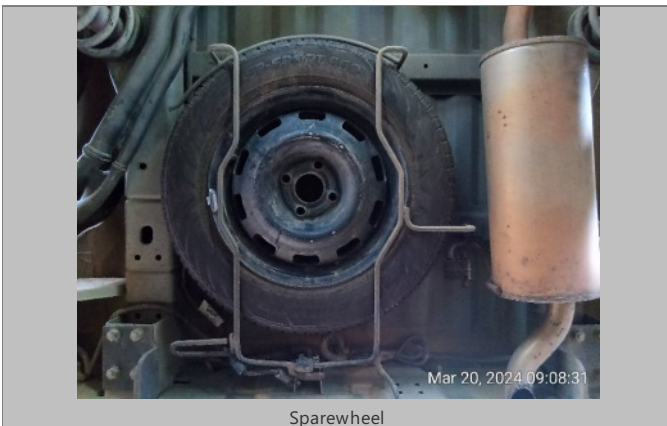
Sparewheel

| | Size | Load/Speed Index | Manufacture | Model | Type* | Production Date | Tread Depth (mm) |
|---|---|---|---|---|---|---|---|
| Spare | 185/65R14 | 86H | DUNLOP | SP SPORT | V | 2216 | 7 mm |
