KOOS & MIKE USED CARS
 , VANDERBIJLPARK
 Gauteng

Assignment

Vehicle Data

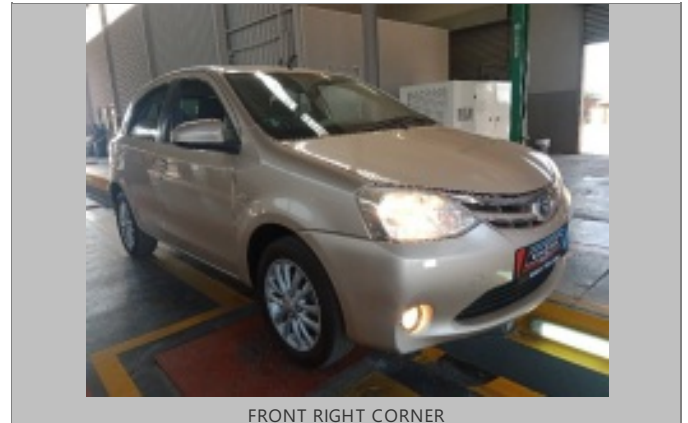
FRONT RIGHT CORNER

Body • Exterior: Vehicle has signs of small dents, chips and scratches on some body panels.

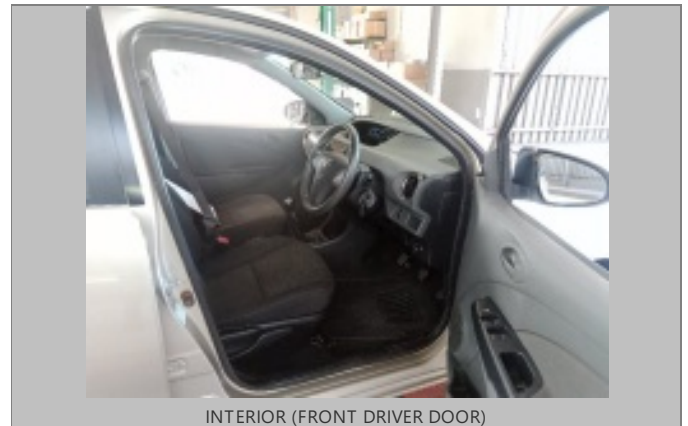
INTERIOR (FRONT DRIVER DOOR)

No negative smell was detected in the vehicle interior. Seats with minor signs of wear including discoloration / fading / stains. Interior trim and/or roof lining and/or carpets show minor signs of wear and/or minor staining. Dashboard with normal signs of wear. The cluster without any defects. The functions of heating and ventilation are without detectable defects. The function of control units and/or instrument cluster is without detectable faults. The testable functions of the air condition is without deficiencies. The function of the electric windows is defect-free. The functions of the electrically adjustable seats and/or seat heaters is defect-free. Service due and the service record incomplete.

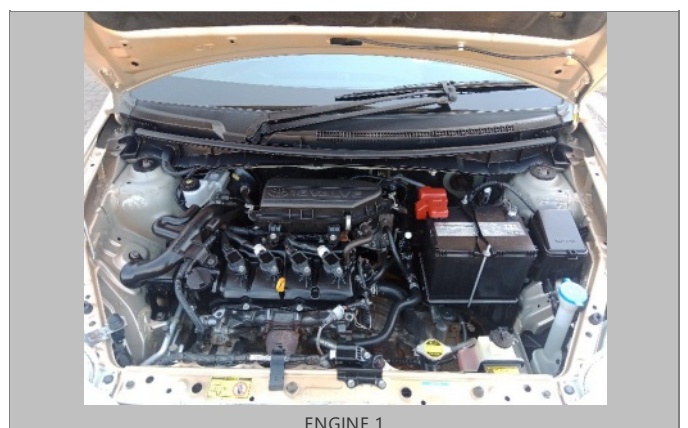
ENGINE 1

The engine-oil level is normal with no visible signs of contamination. The cooling system is without testable defects. The coolant level is normal. The engine shows traces of oil sweat. The gearbox and/or drive shaft show traces of oil sweat. The exhaust system shows signs of damages and/or rust, the functionality is not affected. During the road test no deficiencies were detected on gearshift, clutch, automatic transmissions. During the road test no atypical noises were detected. Minor defects were detected on engine, gearbox, drivetrain - the functionality is not affected.
