KOOS & MIKE USED CARS  
, VANDERBIJLPARK  
Gauteng

Vehicle Type	LIGHT LOAD VEHICLE	Registered Owner	KOOS AND MIKE USED CARS
Manufacturer	NISSAN	Registration Number	HV29RGGP
Model	NP200	Register Number	ZMW596W
VIN	ADNUSN1D5U0157672	Date Of First Licensing	08/01/2019
Engine Number	COVERED	Last COR	
Doors	2	Last COR	08/01/2019
Color	SILVER	License Expiry Date	31/12/2024
Year Model	2018	Power / Displacement	64kw1598cc
Km Reading	80,560 KM	Paint Finish	M - METALLIC
Cab / Body Type	SINGLE CAB	Fuel	PETROL
		Transmission	MANUAL

## VEHICLE INSPECTION

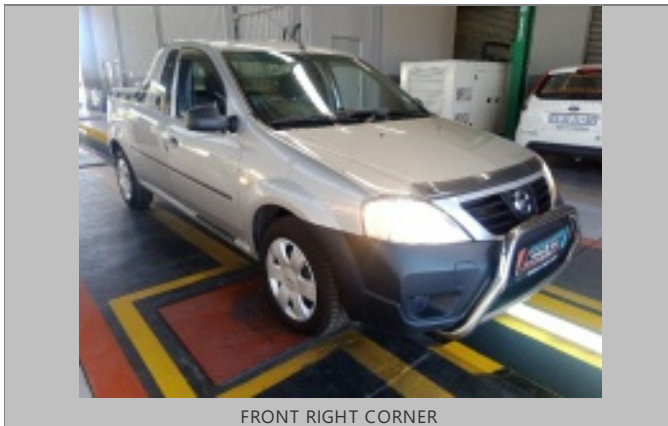
FRONT RIGHT CORNER

Body • Exterior: Minor Dents, Chips and Scratches. Signs of cosmetical improvement on various panels.

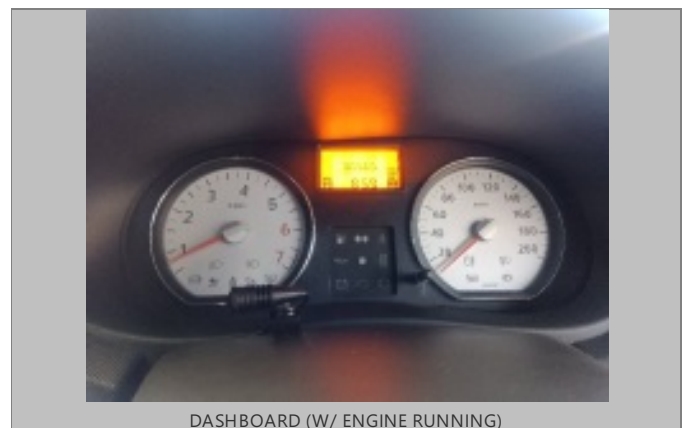
DASHBOARD (W/ ENGINE RUNNING)

No negative smell was detected in the vehicle interior. The condition of the seats is good and the seats show no mechanical defects. Interior trim and/or roof lining and/or carpets show no signs of wear and are in a very well kept overall condition. Dashboard with minor signs of wear. The cluster without any defects. The functions of heating and ventilation are without detectable defects. The function of control units and/or instrument cluster is without detectable faults. The testable functions of the air condition is without deficiencies. The function of the electric windows is defect-free. Defects were detected on the electric seats and/or seat heaters. Service new and the service record incomplete.

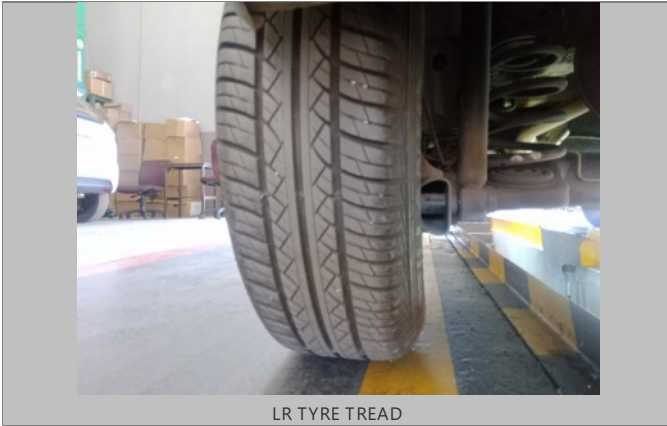
LR TYRE TREAD

Size	Load/Speed Index	Manufacture	Model	Type*	Production Date	Tread Depth (mm)
Front Left	185/65R15	92T	Barum	Brillantis	V	1523	7 mm
Front Right	185/65R15	92T	Barum	Brillantis	V	1523	7 mm
Rear Left	185/65R15	92T	Barum	Brillantis	V	1523	7 mm
Rear Right	185/65R15	92T	Barum	Brillantis	V	1523	7 mm
Spare	185/65R15	92T	Barum	Brillantis	V	0000	8 mm

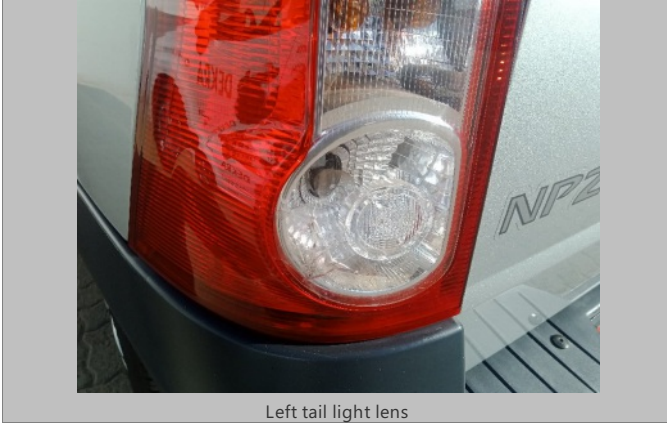
Lights: Left tail light lens cracked observation.
