KOOS & MIKE USED CARS
 , VANDERBIJLPARK
 Gauteng

Assignment

Vehicle Data

VEHICLE INSPECTION

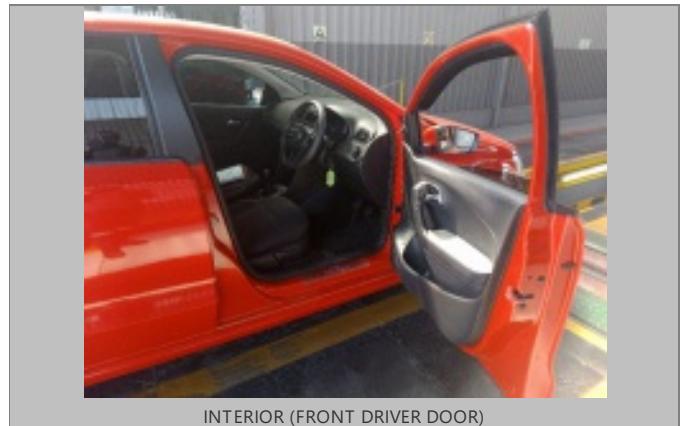
INTERIOR (FRONT DRIVER DOOR)

No negative smell was detected in the vehicle interior. Seats with minor signs of wear including discoloration / fading / stains. Interior trim and/or roof lining and/or carpets show minor signs of wear and/or minor staining. Dashboard with normal signs of wear. The cluster without any defects. The functions of heating and ventilation are without detectable defects. The function of control units and/or instrument cluster is without detectable faults. The testable functions of the air condition is without deficiencies. The function of the electric windows is defect-free. Defects were detected on the electric seats and/or seat heaters. Service due and the service record complete.

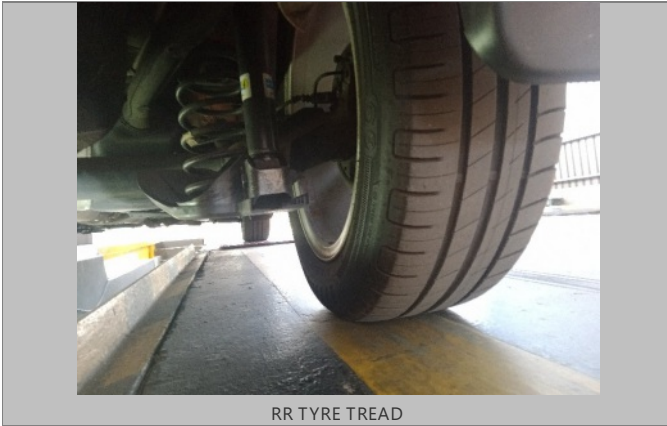
RR TYRE TREAD

Size	Load/Speed Index	Manufacture	Model	Type*	Production Date	Tread Depth (mm)
Front Left	185/60R15	88H	GoodYear	Efficient	V	3021	2 mm
Front Right	185/60R15	88H	GoodYear	Contact	V	3121	2 mm
Rear Left	185/60R15	88H	GoodYear	Efficient	V	3021	3 mm
Rear Right	185/60R15	88H	GoodYear	Efficient	V	3021	4 mm
Spare	175/70R14	84T	Continental	Contact	V	0000	7 mm

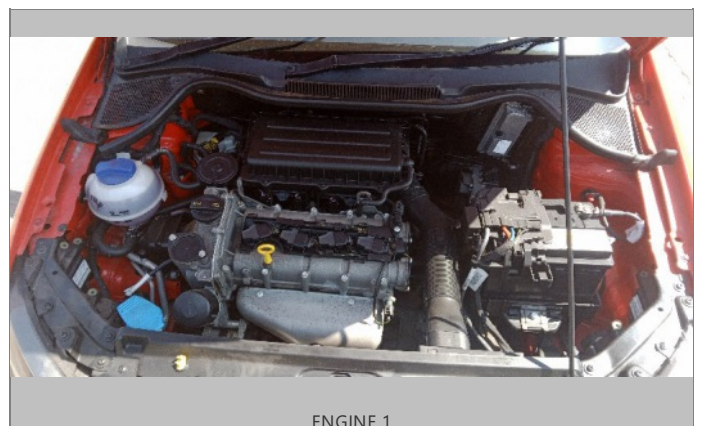
ENGINE 1

The engine-oil level is normal with no visible signs of contamination. The cooling system is without testable defects. The coolant level is normal. The engine shows traces of oil sweat. The gearbox and/or drive shaft show traces of oil sweat. The exhaust system shows signs of damages and/or rust, the functionality is not affected. During the road test no deficiencies were detected on gearshift, clutch, automatic transmissions. During the road test no atypical noises were detected. Minor defects were detected on engine, gearbox, drivetrain - the functionality is not affected.
