KOOS & MIKE USED CARS  
, VANDERBIJLPARK  
Gauteng

### Assignment

### Vehicle Data

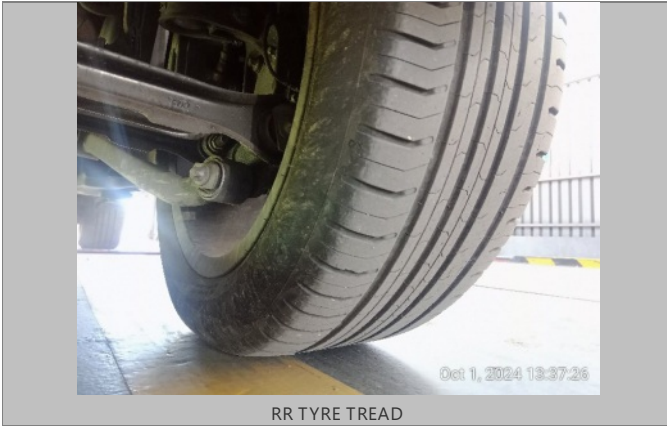
RR TYRE TREAD

Size	Load/Speed Index	Manufacture	Model	Type*	Production Date	Tread Depth (mm)
Front Left	215/55R17	94V	Continental	Contact	V	0220	3 mm
Front Right	215/55R17	94V	Continental	Contact	V	0220	4 mm
Rear Left	215/55R17	94V	Continental	Contact	V	4215	5 mm
Rear Right	215/55R17	94V	Continental	Contact	V	4215	6 mm
Spare	215/55R17	94V	Continental	Contact	V	4215	7 mm

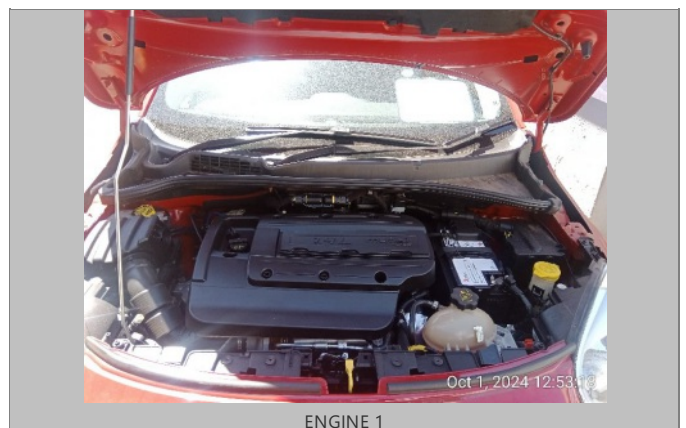
ENGINE 1

Engine number – not possible to verify engine number (not visible without dismantling)
