KOOS & MIKE USED CARS
, VANDERBIJLPARK
Gauteng

Assignment

Vehicle Data

VEHICLE INSPECTION

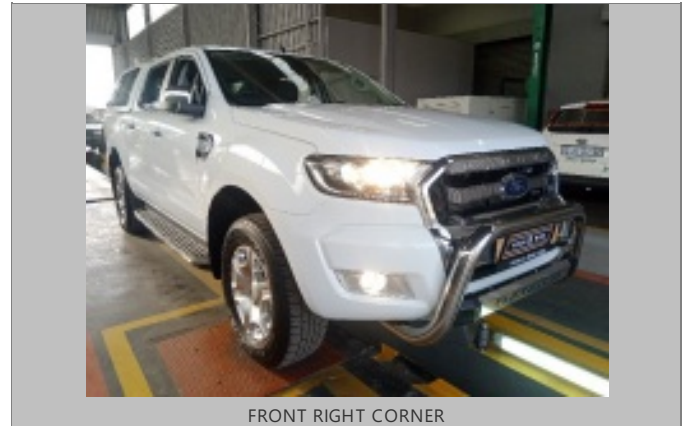
FRONT RIGHT CORNER

Body • Exterior: Vehicle has signs of small dents, chips and scratches on some body panels.

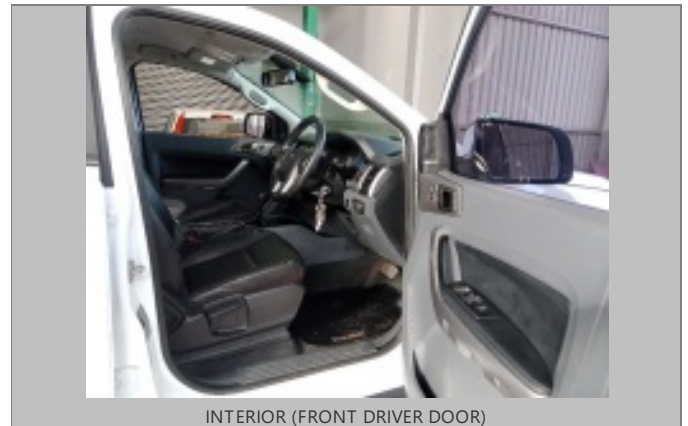
INTERIOR (FRONT DRIVER DOOR)

No negative smell was detected in the vehicle interior. Seats with minor signs of wear including discoloration / fading / stains. Interior trim and/or roof lining and/or carpets show minor signs of wear and/or minor staining. Dashboard with normal signs of wear. The cluster without any defects. The functions of heating and ventilation are without detectable defects. The function of control units and/or instrument cluster is without detectable faults. The testable functions of the air condition is without deficiencies. The function of the electric windows is defect-free. Defects were detected on the electric seats and/or seat heaters. Service due and the service record incomplete.

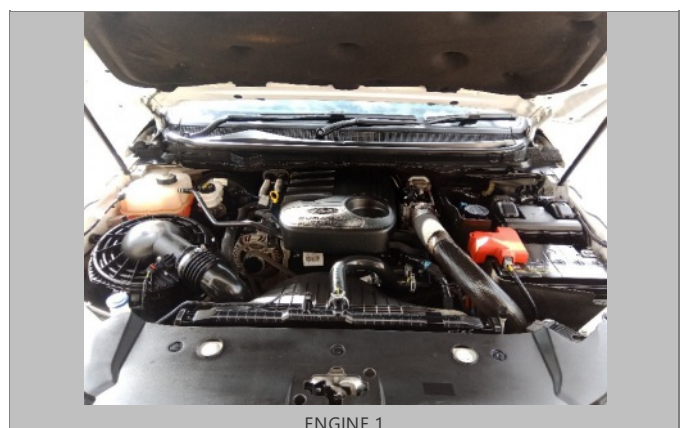
ENGINE 1

The engine-oil level is normal with no visible signs of contamination. The cooling system is without testable defects. The coolant level is normal. The engine shows traces of oil sweat. The gearbox and/or drive shaft show traces of oil sweat. The exhaust system shows signs of damages and/or rust, the functionality is not affected. During the road test no deficiencies were detected on gearshift, clutch, automatic transmissions. During the road test no atypical noises were detected. Minor defects were detected on engine, gearbox, drivetrain - the functionality is not affected.

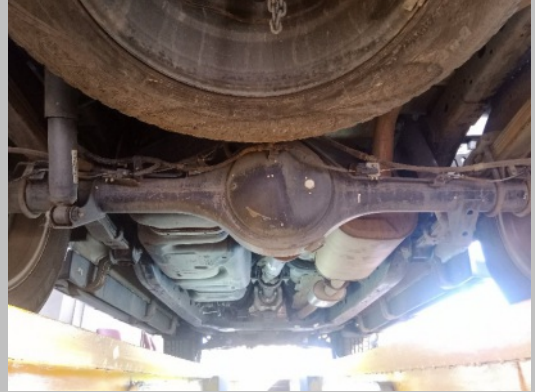
Chassis from the rear

The break fluid level is normal with no visible signs of contamination. Brake pads and discs show signs of wear & tear. The brake pads and/or discs show signs of wear & tear. The undercarriage with minor damages. Minor defects on axles an / or suspension were detected - the functionality is not affected.
