KOOS & MIKE USED CARS
, VANDERBIJLPARK
Gauteng

Assignment

Vehicle Data

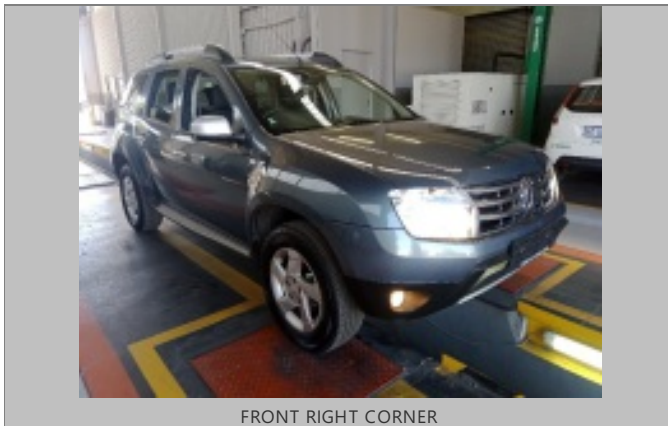
FRONT RIGHT CORNER

Body • Exterior: Minor Dents, Chips and Scratches. Signs of cosmetical improvement on various panels.

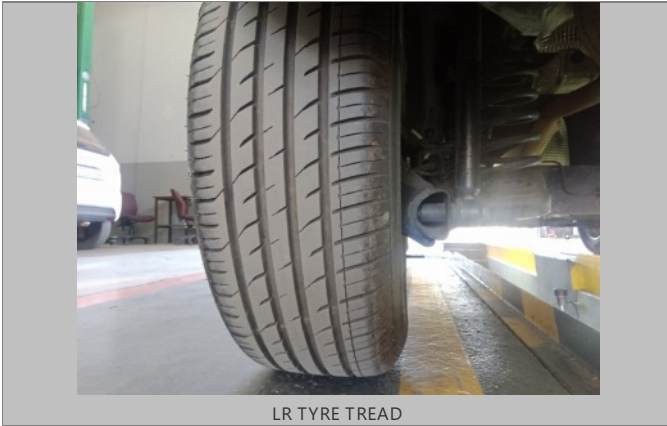
LR TYRE TREAD

Size	Load/Speed Index	Manufacture	Model	Type*	Production Date	Tread Depth (mm)
Front Left	215/65R16	98T	Velocity	Rota R	V	2623	8 mm
Front Right	215/65R16	86T	Velocity	Rota R	V	2623	8 mm
Rear Left	215/65R16	98T	Velocity	Rota R	V	2623	8 mm
Rear Right	215/65R16	98T	Velocity	Rota R	V	2623	8 mm

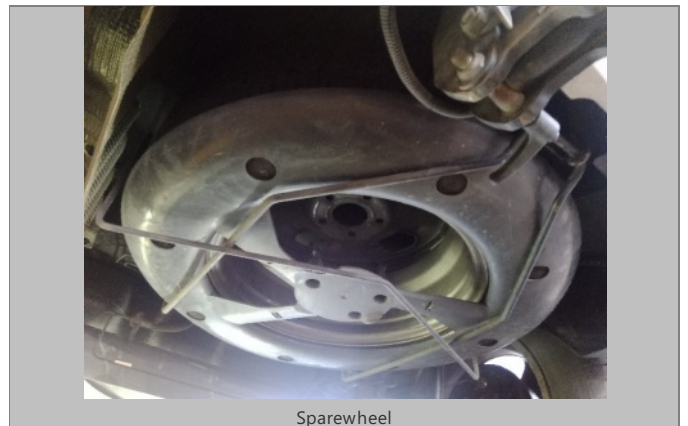
Sparewheel

Tyres and Rims: Spare wheel covered
