KOOS & MIKE USED CARS
, VANDERBIJLPARK
Gauteng

Vehicle Type	PASSENGER VEHICLE	Registered Owner	KOOS & MIKE
Manufacturer	CHERY	Registration Number	LG31XWGP
Model	TIGGO 7 PRO	Register Number	FXT392X
VIN	LVVDB21B0PD068086	Date Of First Licensing	13/07/2023
Engine Number	SQRE4T15CCHNL00718AC	Last COR	
Doors	4	Last COR	2024/08/21
Color	RED	License Expiry Date	30/06/2025
Year Model	2023	Power / Displacement	108kW/1498cc
Km Reading	24,119 KM	Paint Finish	M - METALLIC
Cab / Body Type	STATION WAGON	Fuel	PETROL
		Transmission	AUTOMATIC

VEHICLE INSPECTION

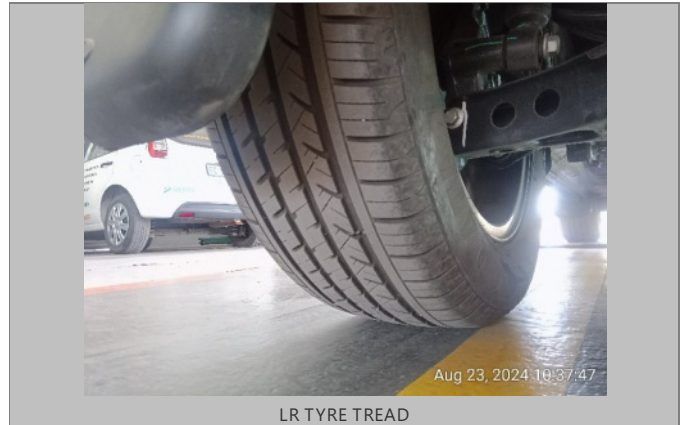
LR TYRE TREAD

Size	Load/Speed Index	Manufacture	Model	Type*	Production Date	Tread Depth (mm)
Front Left	225/60R18	100H	Atlas	Batman	V	4522	5 mm
Front Right	225/60R18	100H	Atlas	Batman	V	4522	5 mm
Rear Left	225/60R18	100H	Atlas	Batman	V	4522	6 mm
Rear Right	225/60R18	100H	Atlas	Batman	V	4522	6 mm
Spare	225/60R18	100H	Atlas	Batman	V	0000	5 mm

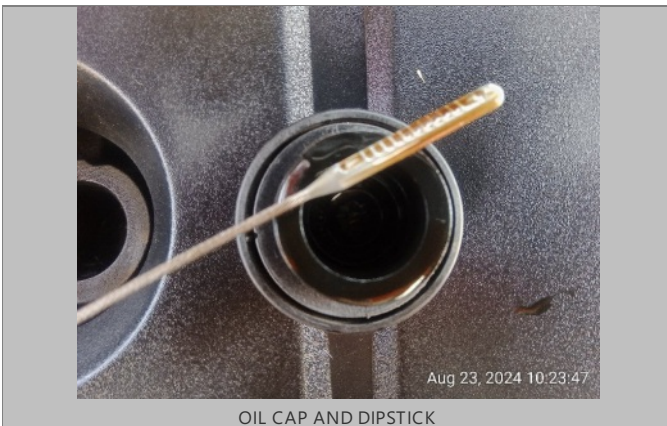
OIL CAP AND DIPSTICK

The engine-oil level is normal with no visible signs of contamination. The cooling system is without testable defects. The coolant level is normal. The engine shows traces of oil sweat. The gearbox and/or drive shaft show traces of oil sweat. The exhaust system shows signs of damages and/or rust, the functionality is not affected. During the road test no deficiencies were detected on gearshift, clutch, automatic transmissions. During the road test no atypical noises were detected. Minor defects were detected on engine, gearbox, drivetrain - the functionality is not affected.

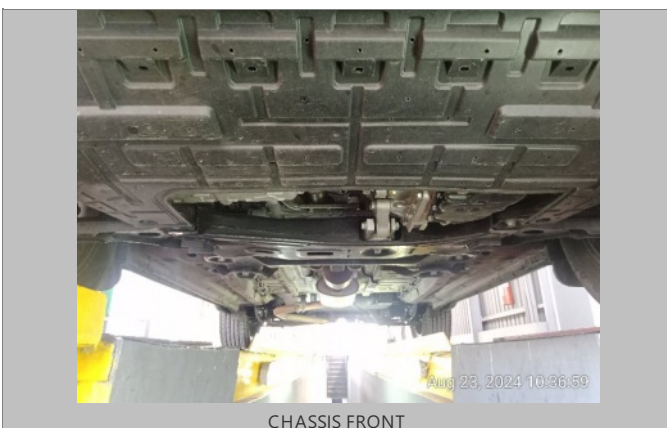
CHASSIS FRONT

The break fluid level is normal with no visible signs of contamination. Brake pads and discs show signs of wear & tear. The brake pads and/or discs show signs of wear & tear. The undercarriage with minor damages. Minor defects on axles an / or suspension were detected - the functionality is not affected.

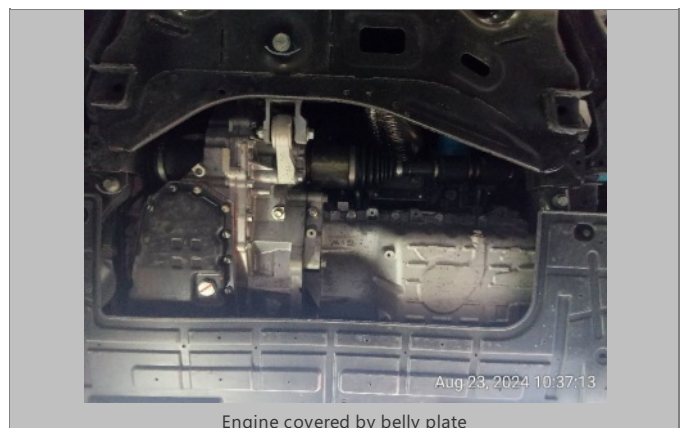
Engine covered by belly plate

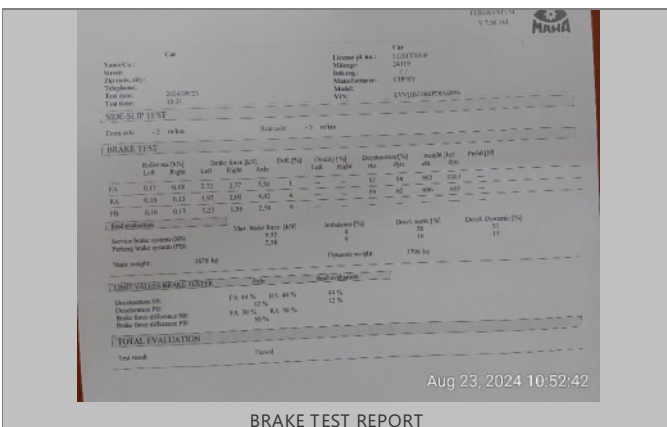
BRAKE TEST REPORT

Left	Right	Axle Weight [KG]	Deceleration [m/s ²]
	Braking Force [KN]	Braking Force [KN]		
Front	2.73	2.77	-	
Rear	1.97	2.05	-	
Emergency / Parking	1.23	1.35	-
