KOOS & MIKE USED CARS
, VANDERBIJLPARK
Gauteng

Vehicle Type	PASSENGER VEHICLE	Registered Owner	KOOS & MIKE
Manufacturer	FORD	Registration Number	CW66BSGP
Model	FOCUS	Register Number	SSL328W
VIN	WF0KXXGCBKDR82903	Date Of First Licensing	02/01/2014
Engine Number	DR82903	Last COR	
Doors	5	Last COR	28/05/2024
Color	WHITE	License Expiry Date	28/02/2025
Year Model	2014	Power / Displacement	184kW/1999cc
Km Reading	149,226 KM	Paint Finish	C - COMMON
Cab / Body Type	HATCHBACK	Fuel	PETROL
		Transmission	MANUAL

VEHICLE INSPECTION

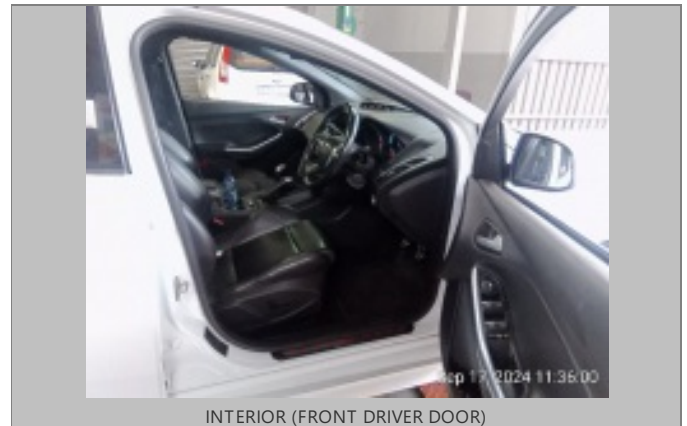
INTERIOR (FRONT DRIVER DOOR)

No negative smell was detected in the vehicle interior. Seats with minor signs of wear including discoloration / fading / stains. Interior trim and/or roof lining and/or carpets show minor signs of wear and/or minor staining. Dashboard with normal signs of wear. The cluster without any defects. The functions of heating and ventilation are without detectable defects. The function of control units and/or instrument cluster is without detectable faults. The testable functions of the air condition is without deficiencies. The function of the electric windows is defect-free. Defects were detected on the electric seats and/or seat heaters. Service due and the service record incomplete.

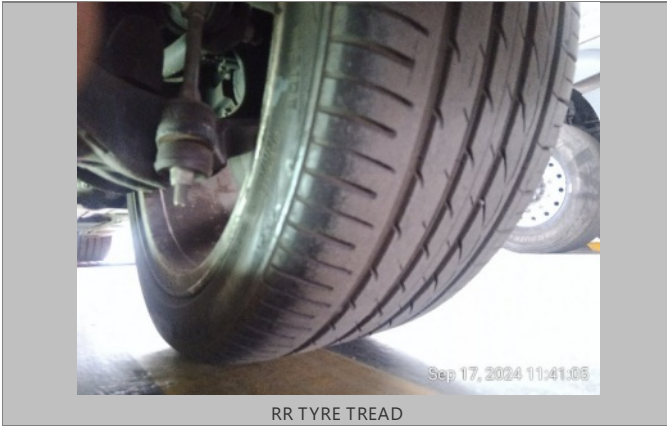
RR TYRE TREAD

Size	Load/Speed Index	Manufacture	Model	Type*	Production Date	Tread Depth (mm)
Front Left	235/40ZR18	95W	Dunlop	Sport	V	1623	5 mm
Front Right	235/40ZR18	95W	Dunlop	Sport	V	1623	5 mm
Rear Left	235/40ZR18	95W	Davanti	SX640	V	3021	3 mm
Rear Right	235/40ZR18	97W	Alventi	Pace	V	1018	3 mm

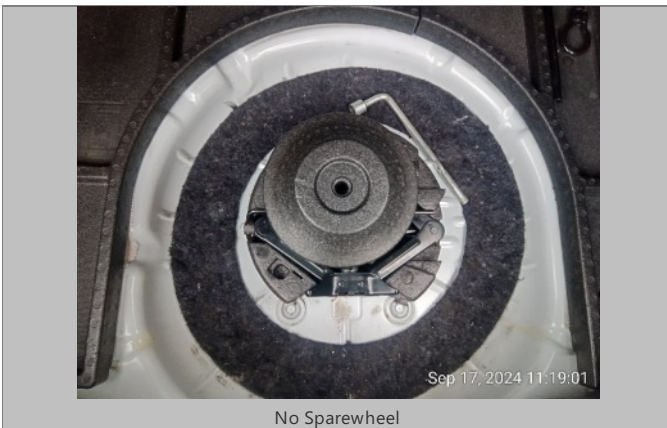
General Comments: ACCORDING TO THE AGE AND MILEAGE OF THE VEHICLE, NORMAL WEAR AND TEAR MARKS ARE VISIBLE ON THE INTERIOR, EXTERIOR, ELECTRICAL AND MECHANICAL PARTS.NO ELECTRICAL ADJUSTABLE SEATS=INSUFFICIENT.NO SPAREWHEEL=INSUFFICIENT.

No Sparewheel

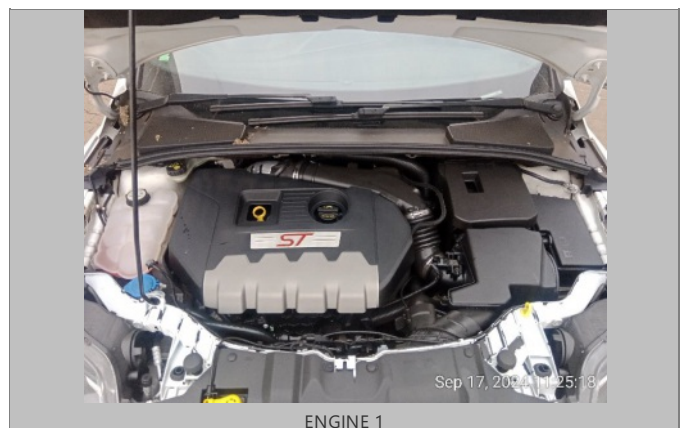
ENGINE 1

The engine-oil level is normal with no visible signs of contamination. The cooling system is without testable defects. The coolant level is normal. The engine shows traces of oil sweat. The gearbox and/or drive shaft show traces of oil sweat. The exhaust system in good condition. During the road test no deficiencies were detected on gearshift, clutch, automatic transmissions. During the road test no atypical noises were detected. Minor defects were detected on engine, gearbox, drivetrain - the functionality is not affected.
