KOOS & MIKE USED CARS
, VANDERBIJLPARK
Gauteng

Vehicle Type	PASSENGER VEHICLE	Registered Owner	KOOS & MIKE
Manufacturer	JEEP	Registration Number	KB98GDGP
Model	CHEROKEE 3.2 LIMITED FWD AT [2014-2020]	Register Number	VXF842W
VIN	1C4PJLHS2FW663479	Date Of First Licensing	21/09/2015
Engine Number	FW663479	Last COR	
Doors	5	Last COR	2020/11/17
Color	SILVER	License Expiry Date	30/06/2023
Year Model	2015	Power / Displacement	200kW/3239cc
Km Reading	173,868 KM	Paint Finish	M - METALLIC
Cab / Body Type	STATION WAGON	Fuel	PETROL
		Transmission	AUTOMATIC

VEHICLE INSPECTION

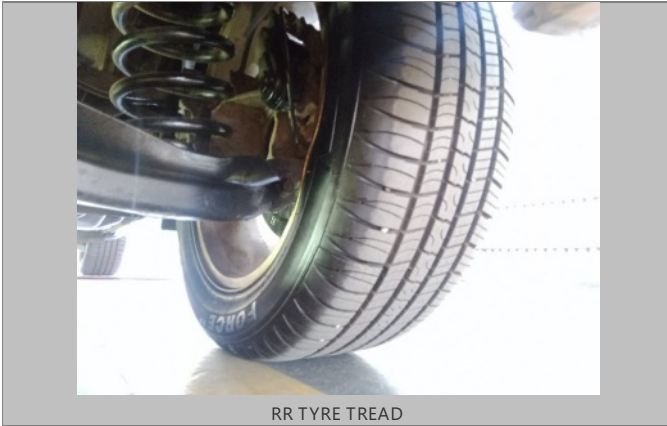
RR TYRE TREAD

Size	Load/Speed Index	Manufacture	Model	Type*	Production Date	Tread Depth (mm)
Front Left	225/55R18	98V	Atlantis	Force	V	4523	10 mm
Front Right	225/55R18	98V	Atlantis	Force	V	4523	9 mm
Rear Left	225/55R18	98V	Atlantis	Force	V	4523	9 mm
Rear Right	225/55R18	98V	Atlantis	Force	V	4523	9 mm
Spare	225/60R17	99V	Michelin	Primacy	V	0000	7 mm

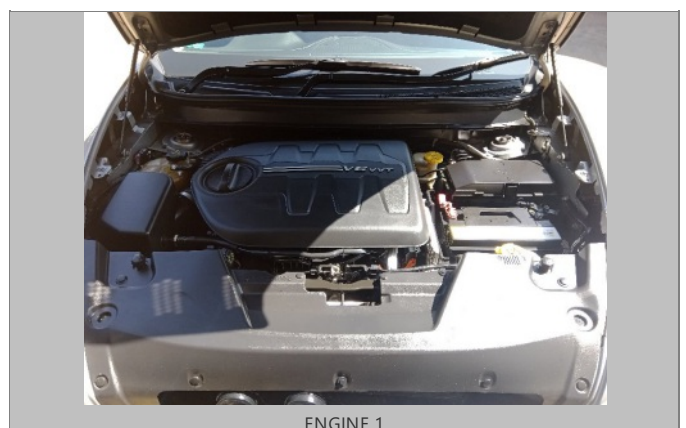
ENGINE 1

The engine-oil level is normal with no visible signs of contamination. The cooling system is without testable defects. The coolant level is normal. The engine shows traces of oil sweat. The gearbox and/or drive shaft show traces of oil sweat. The exhaust system shows signs of damages and/or rust, the functionality is not affected. During the road test no deficiencies were detected on gearshift, clutch, automatic transmissions. During the road test no atypical noises were detected. Minor defects were detected on engine, gearbox, drivetrain - the functionality is not affected.

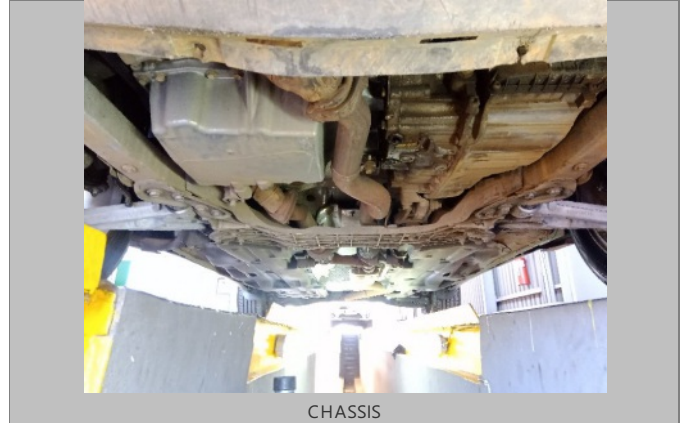
CHASSIS

The brake fluid level is normal with no visible signs of contamination. Brake pads and discs show signs of wear & tear. The brake pads and/or discs show signs of wear & tear. The undercarriage with minor damages. Minor defects on axles an / or suspension were detected - the functionality is not affected.
