KOOS & MIKE USED CARS
, VANDERBIJLPARK
Gauteng

Assignment

Vehicle Data

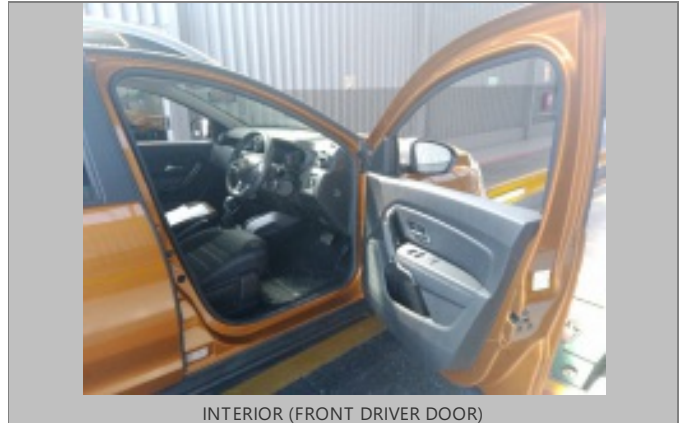
INTERIOR (FRONT DRIVER DOOR)

No negative smell was detected in the vehicle interior. Seats with minor signs of wear including discoloration / fading / stains. Interior trim and/or roof lining and/or carpets show minor signs of wear and/or minor staining. Dashboard with normal signs of wear. The cluster without any defects. The functions of heating and ventilation are without detectable defects. The function of control units and/or instrument cluster is without detectable faults. The testable functions of the air condition is without deficiencies. The function of the electric windows is defect-free. Defects were detected on the electric seats and/or seat heaters. Service due and the service record complete.

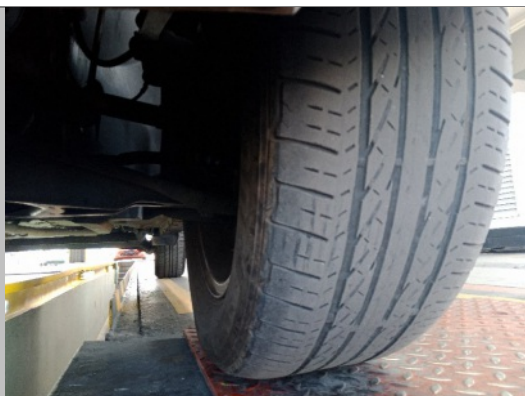
LF TYRE TREAD

Size	Load/Speed Index	Manufacture	Model	Type*	Production Date	Tread Depth (mm)
Front Left	215/60R17	96H	Bridgestone	Dueler	V	3919	2 mm
Front Right	215/60R17	96H	Bridgestone	Dueler	V	3919	1 mm
Rear Left	215/60R17	96T	Blackhawk	Street H	V	0921	5 mm
Rear Right	215/60R17	86H	Bridgestone	Dueler	V	3919	4 mm
Spare	215/65R16	98H	Continental	Cross contac	V	4719	7 mm

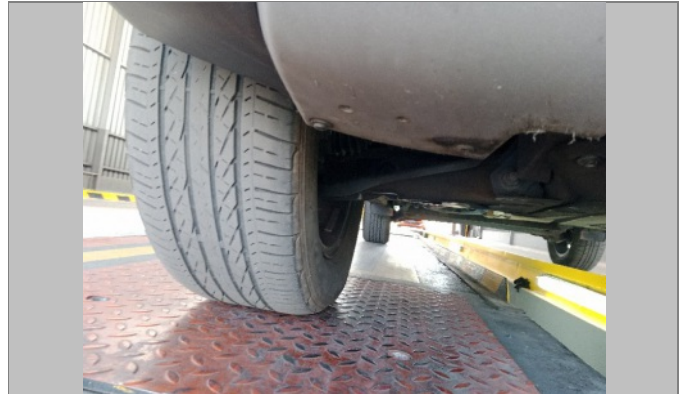
RF TYRE TREAD

The rims show no defects which affect the function. The mechanics of doors / bonnet / tailgate are defect-free. No residual traces of damage repair were detected. The vehicle shows normal signs of wear & tear according to age and milage. Vehicle Body with several dents or scratches or corrosion (edge corrosion / surface corroded). Minor paint damage to the primer were detected. The glass panes have stone chips and/or scratches. Hang-on parts (grill, bumpers, mirrors, antennas, strips, etc.) show minor damages. The spare tire / emergency wheel / repair set shows signs of wear & tear. The tire tread depth is less than 1 mm or the tires are damaged.

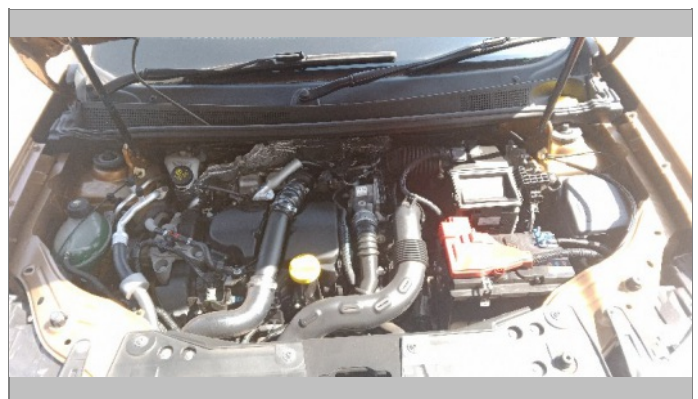
ENGINE 1

The engine-oil level is normal with no visible signs of contamination. The cooling system is without testable defects. The coolant level is normal. The engine shows traces of oil sweat. The gearbox and/or drive shaft show traces of oil sweat. The exhaust system shows signs of damages and/or rust, the functionality is not affected. During the road test no deficiencies were detected on gearshift, clutch, automatic transmissions. During the road test no atypical noises were detected. Minor defects were detected on engine, gearbox, drivetrain - the functionality is not affected.
