KOOS & MIKE USED CARS
, VANDERBIJLPARK
Gauteng

Vehicle Type	PASSENGER VEHICLE	Registered Owner	KOOS & MIKE
Manufacturer	CHEVROLET	Registration Number	FH76GSGP
Model	UTILITY	Register Number	GTN446K
VIN	ADMCF4MR8G4774191	Date Of First Licensing	15/06/2016
Engine Number	GK7002358	Last COR	
Doors	2	Last COR	21/10/2024
Color	WHITE	License Expiry Date	31/01/2025
Year Model	2016	Power / Displacement	68kW. 1389cc
Km Reading	103,994 KM	Paint Finish	C - COMMON
Cab / Body Type	SINGLE CAB	Fuel	PETROL
		Transmission	MANUAL

VEHICLE INSPECTION

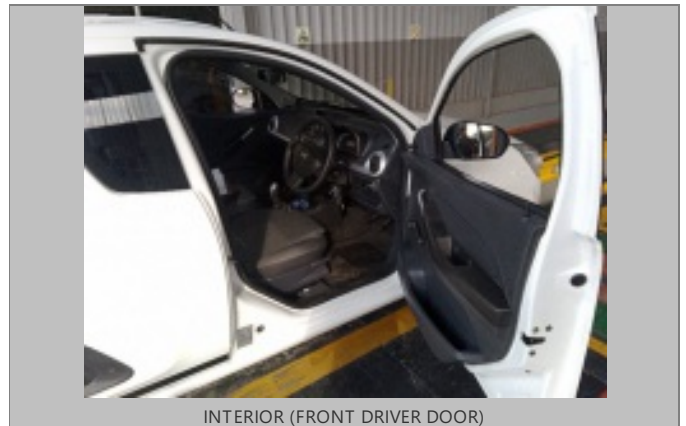
INTERIOR (FRONT DRIVER DOOR)

No negative smell was detected in the vehicle interior. Seats with minor signs of wear including discoloration / fading / stains. Interior trim and/or roof lining and/or carpets show minor signs of wear and/or minor staining. Dashboard with normal signs of wear. The cluster without any defects. The functions of heating and ventilation are without detectable defects. The function of control units and/or instrument cluster is without detectable faults. The testable functions of the air condition is without deficiencies. Defects were detected on the electric seats and/or seat heaters. Service due and the service record complete.

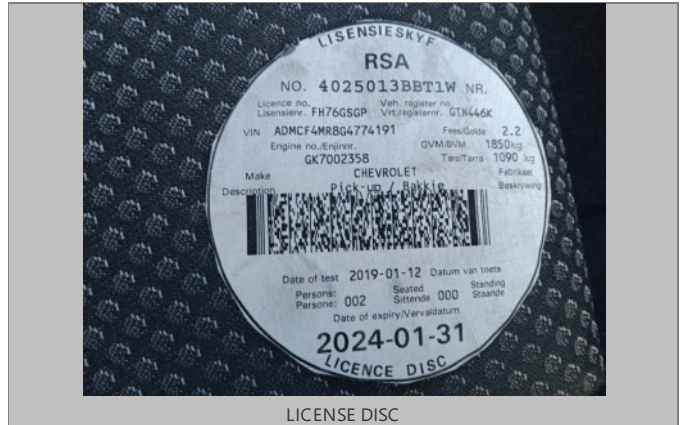
LICENSE DISC

LISENSIESKVF
RSA
NO. 4025013BBT1W NR.
Licence no. / Lisensier. FH76GSGP Veh. register no. / Vrt. registrernr. GTN446K
VIN ADMCF4MR8G4774191 Fiesse/Gelde 2,2
Engine no./Enjinnr. GK7002358 GVMBVM 1850kg
Tara/Terra 1090 kg
Make CHEVROLET Fabriek
Description Pick Up / Bakkie Bestrywing
Date of test 2019-01-12 Datum van toets
Persons: 002 Seated Sitende
Date of expiry/Vervaldatum 000 Standing Staande
2024-01-31
LICENCE DISC

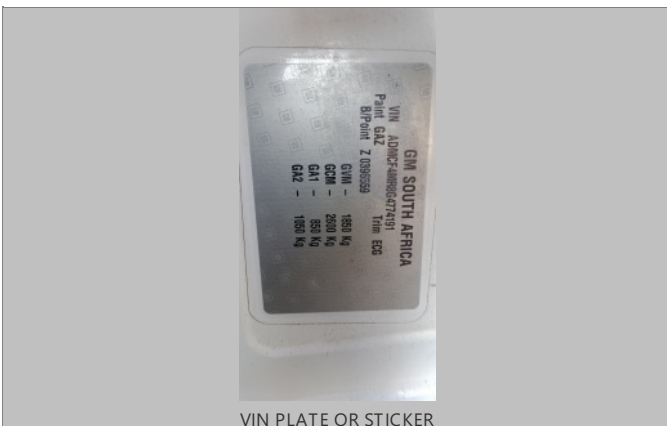
VIN PLATE OR STICKER

GWM SOUTH AFRICA
VIN ADMCF4MR8G4774191
Paint GAZ
B/Paint 2 0395539
GVM 1981 kg
GCM 2000 kg
GAT 851 kg
GAX 1181 kg
Tara EGS
