KOOS & MIKE USED CARS
, VANDERBIJLPARK
Gauteng

DEKRA Vanderbijl Park
Jorissen Str - 1911
VANDERBIJLPARK - GT
016 931 3126

Assignment

VEHICLE INSPECTION

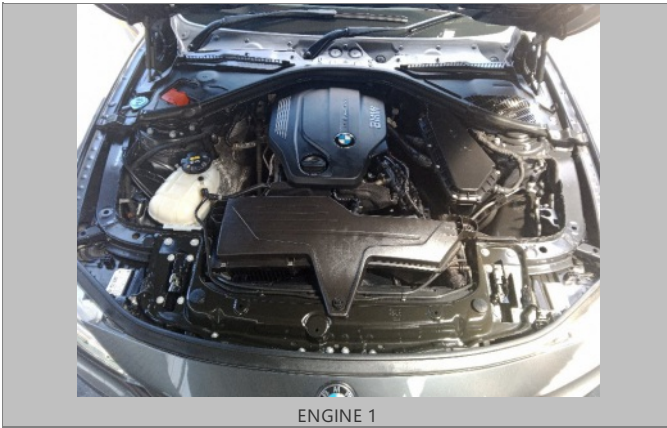
ENGINE 1

The engine-oil level is normal with no visible signs of contamination. The cooling system is without testable defects. The coolant level is normal. The engine shows traces of oil sweat. The gearbox and/or drive shaft show traces of oil sweat. The exhaust system shows signs of damages and/or rust, the functionality is not affected. During the road test no deficiencies were detected on gearshift, clutch, automatic transmissions. During the road test no atypical noises were detected. Minor defects were detected on engine, gearbox, drivetrain - the functionality is not affected.

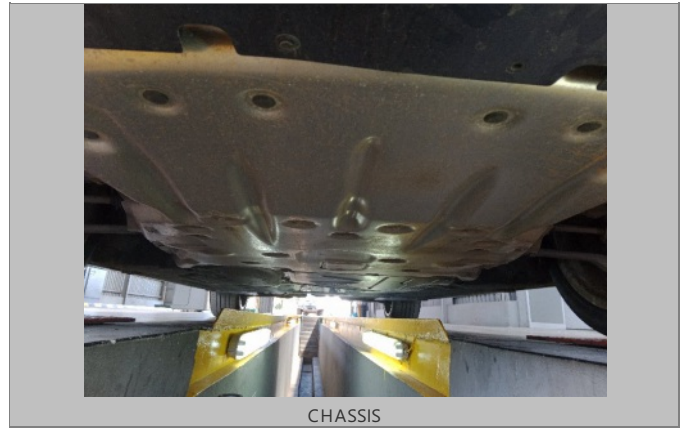
CHASSIS

The break fluid level is normal with no visible signs of contamination. Brake pads and discs show signs of wear & tear. The brake pads and/or discs show signs of wear & tear. No damages detected at the undercarriage or undercarriage protection. Axles, Suspension are in a good condition.
