KOOS & MIKE USED CARS  
 , VANDERBIJLPARK  
 Gauteng

DEKRA Vanderbijl Park  
 Jorissen Str - 1911  
 VANDERBIJLPARK - GT  
 016 931 3126

**Assignment**

**Vehicle Data**

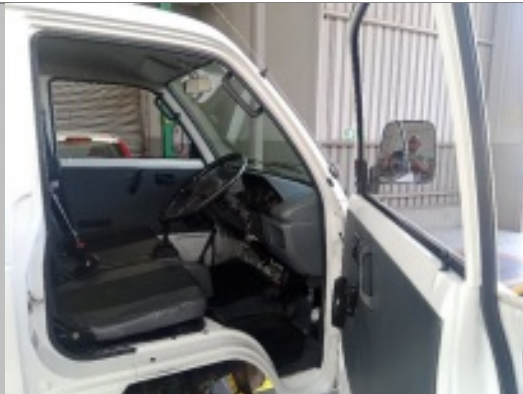
INTERIOR (FRONT DRIVER DOOR)

No negative smell was detected in the vehicle interior. Seats with minor signs of wear including discoloration / fading / stains. Interior trim and/or roof lining and/or carpets show minor signs of wear and/or minor staining. Dashboard with normal signs of wear. The cluster without any defects. The functions of heating and ventilation are without detectable defects. The function of control units and/or instrument cluster is without detectable faults. Defects were detected on the electric seats and/or seat heaters. Service due and the service record incomplete.

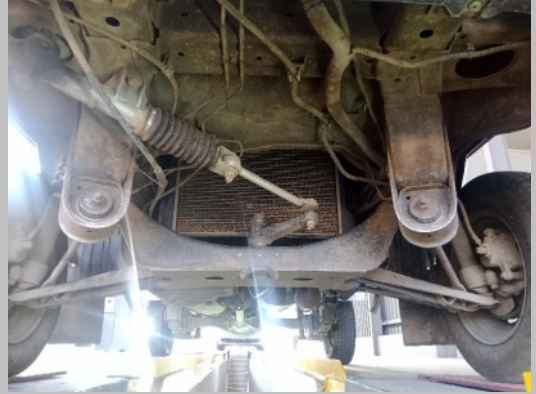
Chassis from the front

The break fluid level is normal with no visible signs of contamination. Brake pads and discs show signs of wear & tear. The brake pads and/or discs show signs of wear & tear. The undercarriage with minor damages. Minor defects on axles an / or suspension were detected - the functionality is not affected.

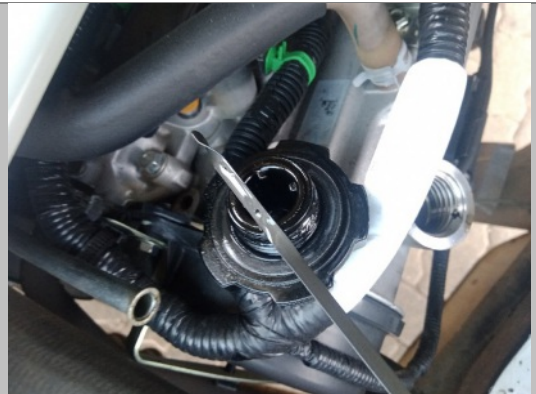
Oil filler cap and Dipstick

The engine-oil level is normal with no visible signs of contamination. The cooling system is without testable defects. The coolant level is normal. The engine shows traces of oil sweat. The gearbox and/or drive shaft show traces of oil sweat. The exhaust system shows signs of damages and/or rust, the functionality is not affected. During the road test no deficiencies were detected on gearshift, clutch, automatic transmissions. During the road test no atypical noises were detected. Minor defects were detected on engine, gearbox, drivetrain - the functionality is not affected.
