KOOS & MIKE USED CARS
, VANDERBIJLPARK
Gauteng

Assignment

Vehicle Data

VEHICLE INSPECTION

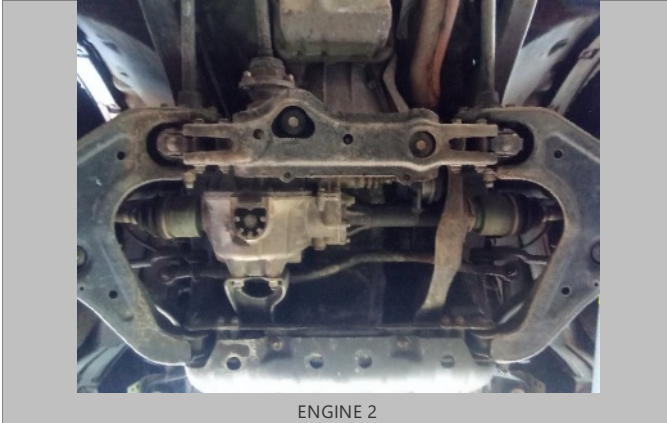
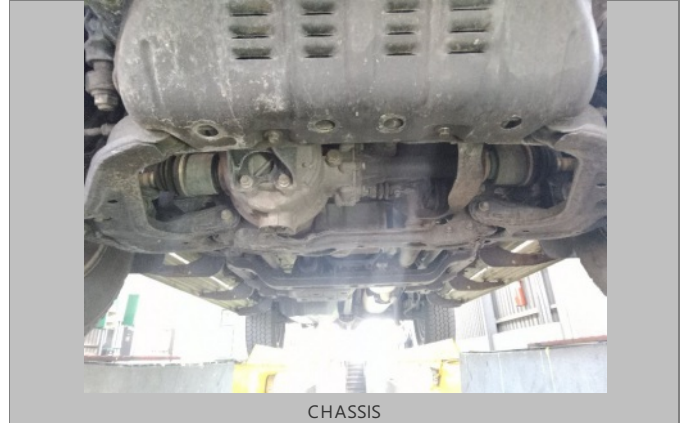
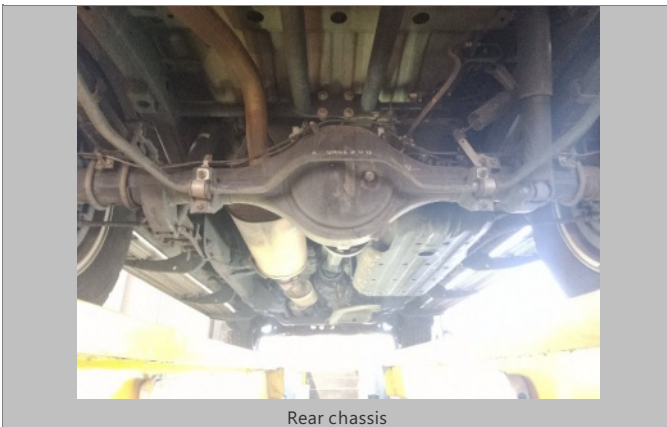
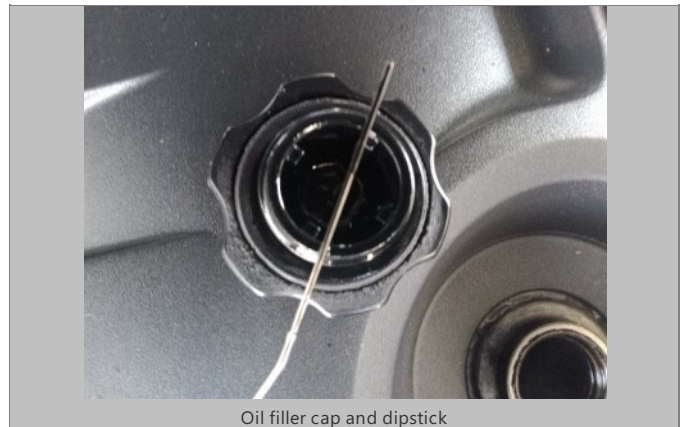
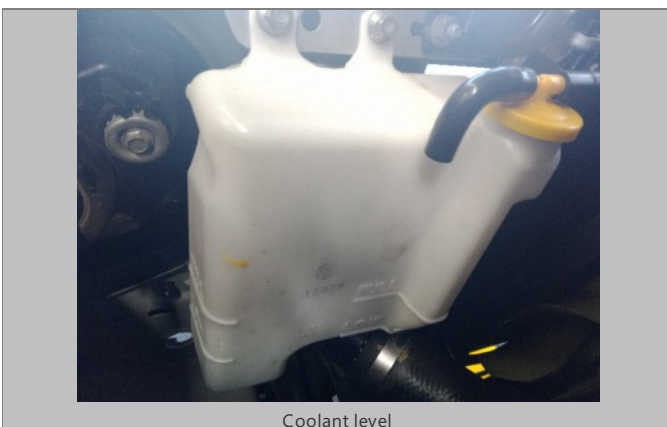
ENGINE 1

The engine-oil level is normal with no visible signs of contamination. The cooling system is without testable defects. The coolant level is normal. The engine shows traces of oil sweat. The gearbox and/or drive shaft show traces of oil sweat. The exhaust system shows signs of damages and/or rust, the functionality is not affected. During the road test no deficiencies were detected on gearshift, clutch, automatic transmissions. During the road test no atypical noises were detected. Minor defects were detected on engine, gearbox, drivetrain - the functionality is not affected.
