KOOS & MIKE USED CARS
, VANDERBIJLPARK
Gauteng

Assignment

Client	KOOS & MIKE USED CARS	Inspection Location	DEKRA Vanderbijl Park Jorissen Street - 1911 Vanderbijlpark -
Requested Date	25/09/2024		
Inspection Date	25/09/2024

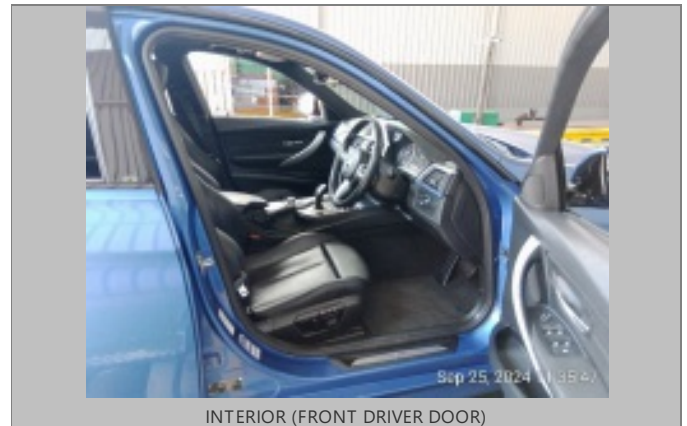
INTERIOR (FRONT DRIVER DOOR)

No negative smell was detected in the vehicle interior. Seats with minor signs of wear including discoloration / fading / stains. Interior trim and/or roof lining and/or carpets show minor signs of wear and/or minor staining. Dashboard with normal signs of wear. The cluster without any defects. The functions of heating and ventilation are without detectable defects. The function of control units and/or instrument cluster is without detectable faults. The testable functions of the air condition is without deficiencies. The function of the electric windows is defect-free. The function of electric sunroof and/or electric soft top is defect-free. The functions of the electrically adjustable seats and/or seat heaters is defect-free. Service due and the service record complete.

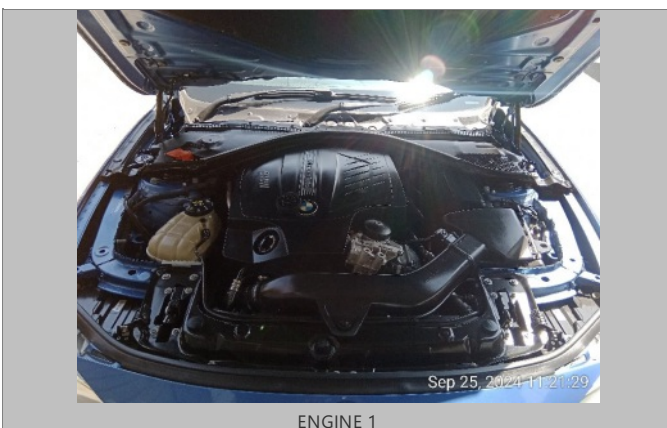
ENGINE 1

The engine-oil level is normal with no visible signs of contamination. The cooling system is without testable defects. The coolant level is normal. The engine shows traces of oil sweat. The gearbox and/or drive shaft show traces of oil sweat. The exhaust system shows signs of damages and/or rust, the functionality is not affected. During the road test no deficiencies were detected on gearshift, clutch, automatic transmissions. During the road test no atypical noises were detected. Minor defects were detected on engine, gearbox, drivetrain - the functionality is not affected.
