KOOS & MIKE USED CARS  
, VANDERBIJLPARK  
Gauteng

DEKRA Vanderbijl Park  
Jorissen Str - 1911  
VANDERBIJLPARK - GT  
016 931 3126

## VEHICLE INSPECTION

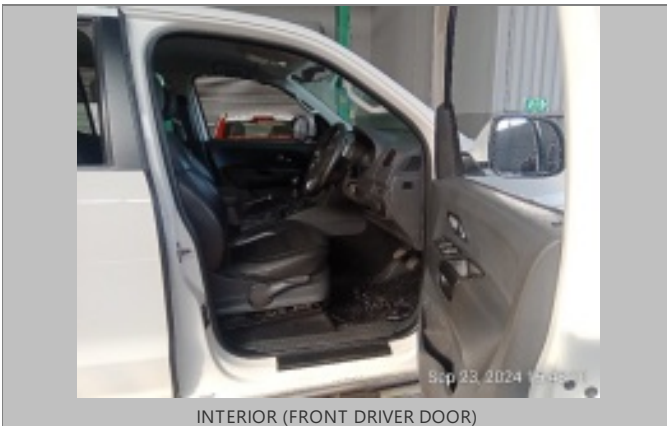
INTERIOR (FRONT DRIVER DOOR)

No negative smell was detected in the vehicle interior. Seats with minor signs of wear including discoloration / fading / stains. Interior trim and/or roof lining and/or carpets show minor signs of wear and/or minor staining. Dashboard with normal signs of wear. The cluster without any defects. The functions of heating and ventilation are without detectable defects. The function of control units and/or instrument cluster is without detectable faults. The testable functions of the air condition is without deficiencies. The function of the electric windows is defect-free. The function of electric sunroof and/or electric soft top is defect-free. Defects were detected on the electric seats and/or seat heaters. Service due and the service record incomplete.

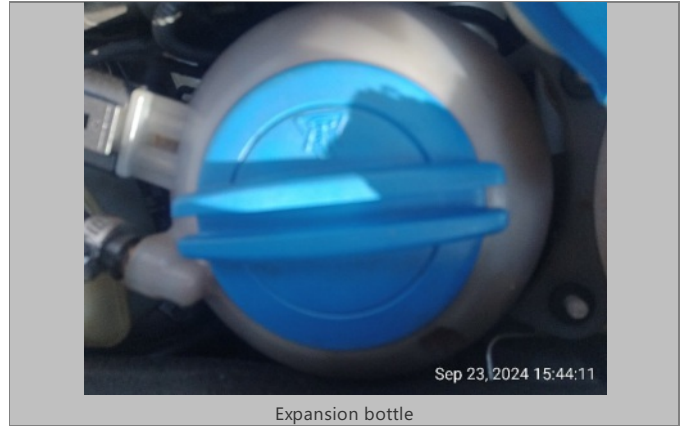
Expansion bottle

The engine-oil level is normal with no visible signs of contamination. The cooling system is without testable defects. The coolant level is normal. The engine shows traces of oil sweat. The gearbox and/or drive shaft show traces of oil sweat. The exhaust system shows signs of damages and/or rust, the functionality is not affected. During the road test no deficiencies were detected on gearshift, clutch, automatic transmissions. During the road test no atypical noises were detected. Minor defects were detected on engine, gearbox, drivetrain - the functionality is not affected.
