KOOS & MIKE USED CARS
, VANDERBIJLPARK
Gauteng

Assignment

VEHICLE INSPECTION

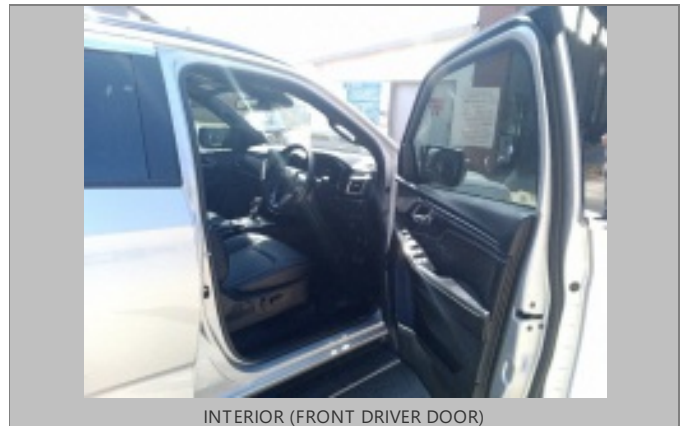
INTERIOR (FRONT DRIVER DOOR)

No negative smell was detected in the vehicle interior. Seats with minor signs of wear including discoloration / fading / stains. Interior trim and/or roof lining and/or carpets show minor signs of wear and/or minor staining. Dashboard with normal signs of wear. The cluster without any defects. The functions of heating and ventilation are without detectable defects. The function of control units and/or instrument cluster is without detectable faults. The testable functions of the air condition is without deficiencies. The function of the electric windows is defect-free. The functions of the electrically adjustable seats and/or seat heaters is defect-free. Service due and the service record complete.

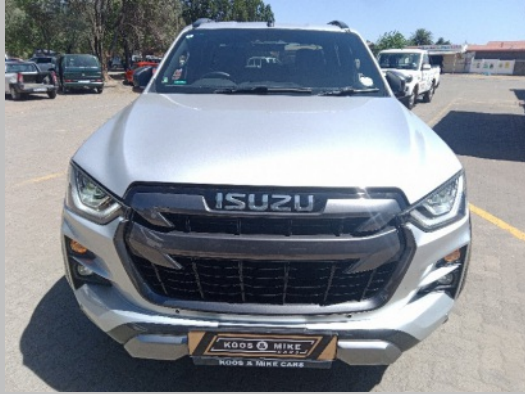
90 DEGREE FRONT

The rims show no defects which affect the function. The mechanics of doors / bonnet / tailgate are defect-free. No residual traces of damage repair were detected. The vehicle shows normal signs of wear & tear according to age and milage. Vehicle Body with several dents or scratches or corrosion (edge corrosion / surface corroded). Minor paint damage to the primer were detected. The glass panes show minor signs of wear and scratches. Hang-on parts (grill, bumpers, mirrors, antennas, strips, etc.) show minor damages. The spare wheel / Emergency Wheel / Repair Set is in good condition. The tire tread depth is more than 1 mm. The tires are in good condition
